Americans with Disabilities Act Transition Plan

City of Highland
1115 Broadway
P.O. Box 218
Highland, IL 62249-0218

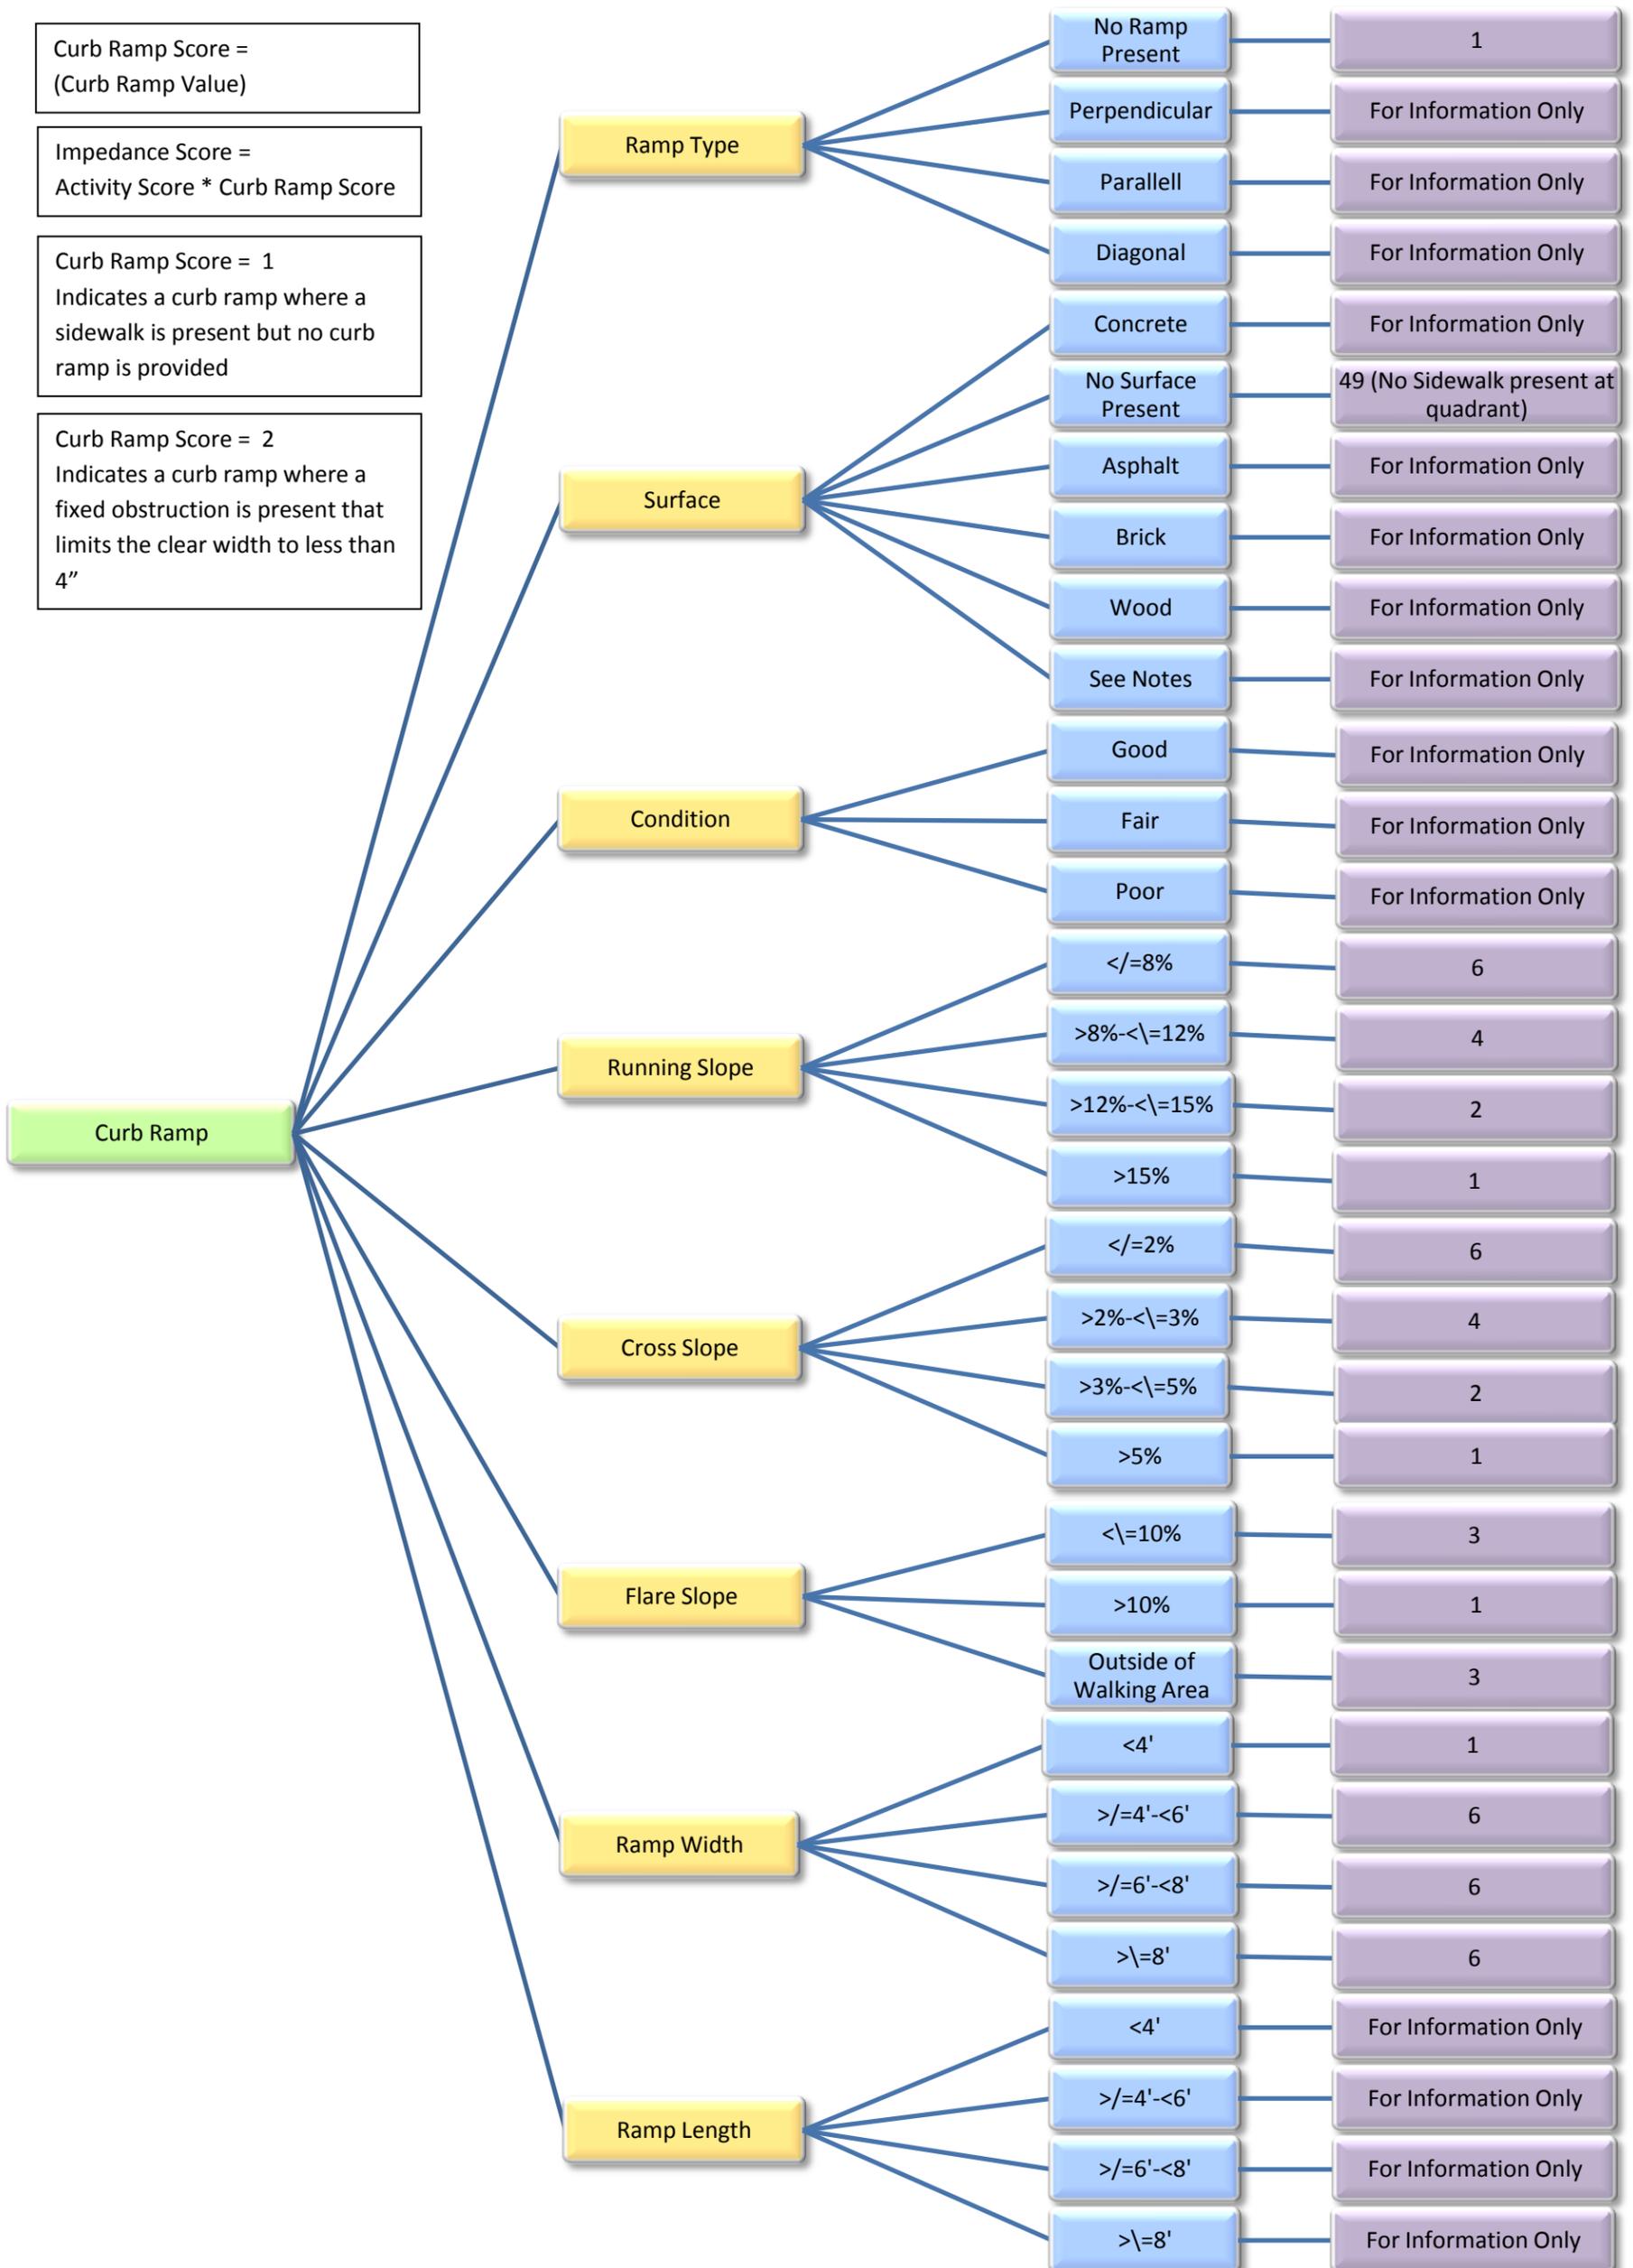
This is the first sheet of curb ramp data. Curb ramps were divided into 2 sheets to provide clarity. The following is a graphical representation of the curb ramp data to be collected as part of the transition plan. The main node at the left side of the chart "Curb Ramps" represents the feature for which the data is being collected. The nodes directly right of "Curb Ramps" (i.e. Surface, Condition, etc.) represents the attributes that will be collected. The data right of the attribute nodes (i.e. Concrete, Asphalt, etc.) represents the various options that will be presented to the field crew via drop down menu. The data at the far right represent the point value that will be assigned to the various deficiencies; if the curb ramp does not have a curb ramp present than a score of 1 will be assigned. If an obstruction is present a score value of 2 points will be assigned. A surface of "no surface present" represents that no sidewalk is present at the curb ramp and forty-nine points will be deducted from the score. The max score of fifty points represents a curb ramp that has no deficiencies.

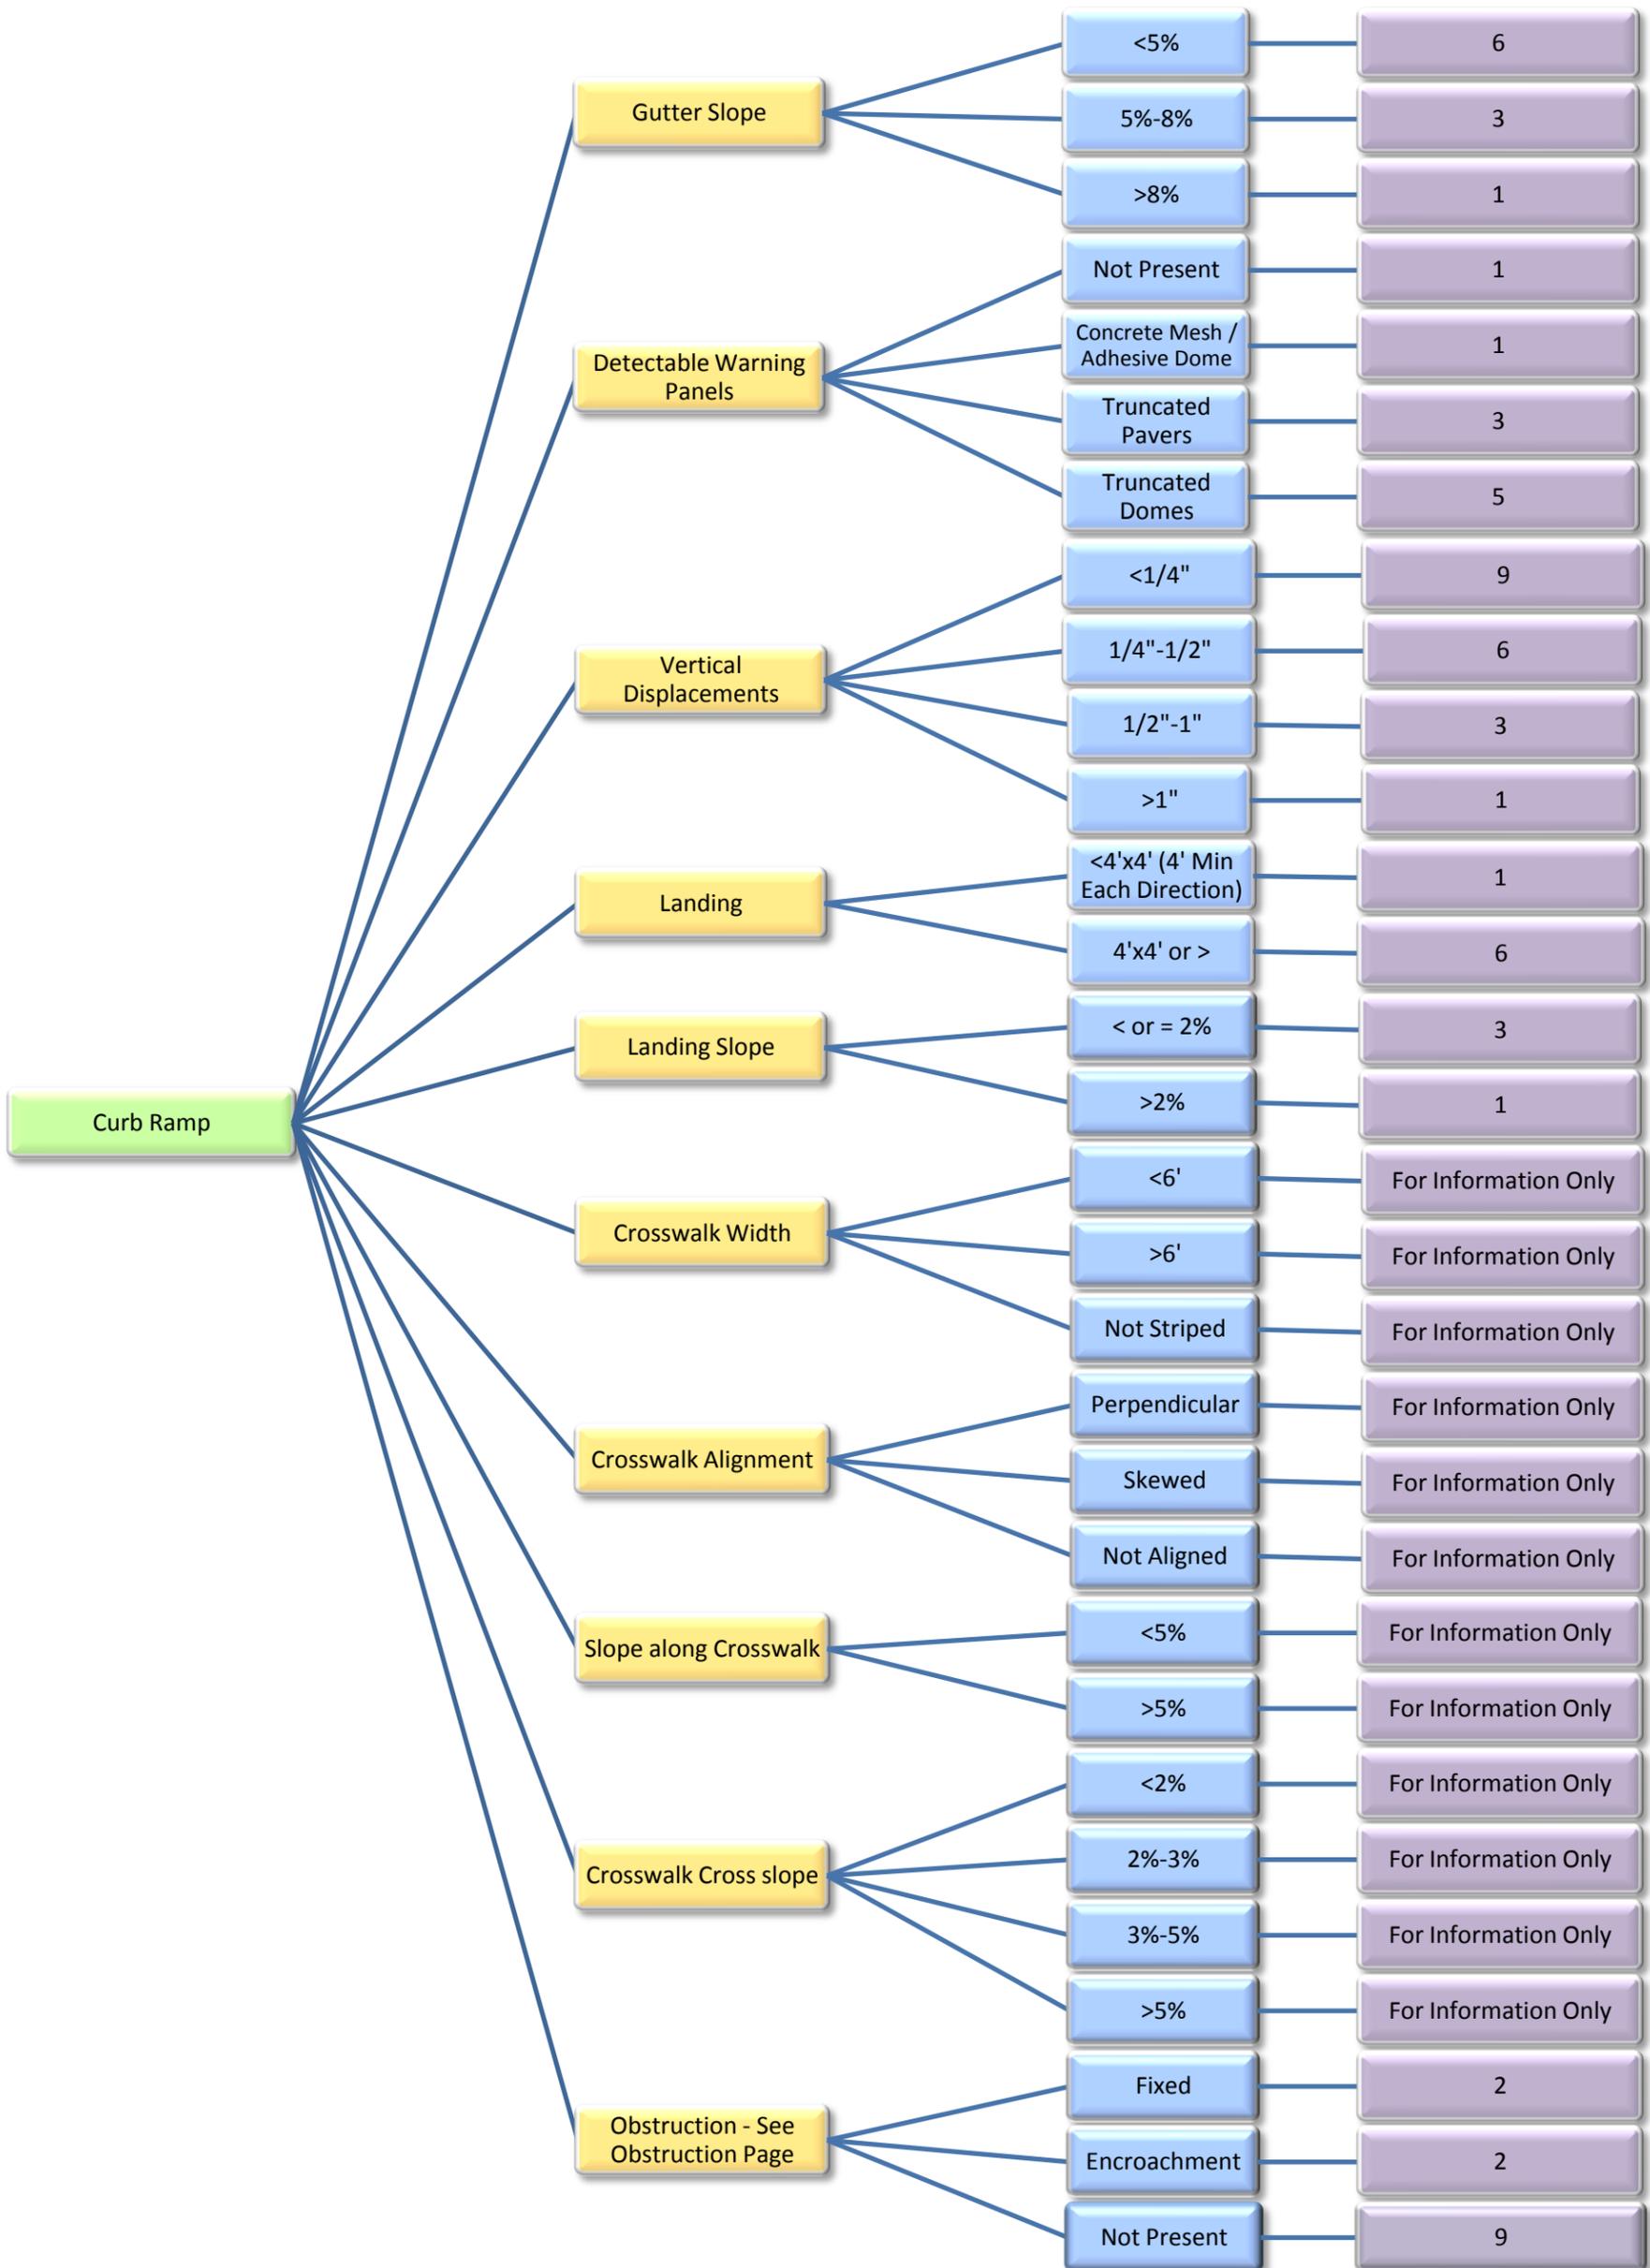
CURB RAMP DATA SCORING FLOW CHART (SHEET 2)

This is the first sheet of curb ramp data. Curb ramps were divided into 2 sheets to provide clarity. The following is a graphical representation of the curb ramp data to be collected as part of the transition plan. The main node at the left side of the chart "Curb Ramps" represents the feature for which the data is being collected. The nodes directly right of "Curb Ramps" (i.e. Surface, Condition, etc.) represents the attributes that will be collected. The data right of the attribute nodes (i.e. Concrete, Asphalt, etc.) represents the various options that will be presented to the field crew via drop down menu. The data at the far right represent the point value that will be assigned to the various deficiencies; if the curb ramp does not have a curb ramp present than a score of 1 will be assigned. If an obstruction is present a score value of 2 points will be assigned. A surface of "no surface present" represents that no sidewalk is present at the curb ramp and forty-nine points will be deducted from the score. The max score of fifty points represents a curb ramp that has no deficiencies.

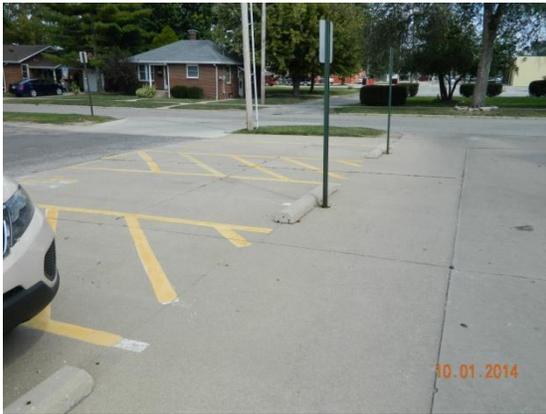
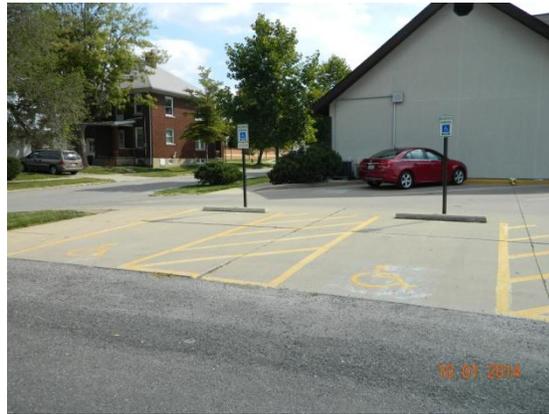
• 1.11

Non-compliance: There are no signs that read "van accessible" at the accessible parking sign.

Solution: Provide signs that read "van accessible".

Cost: \$50

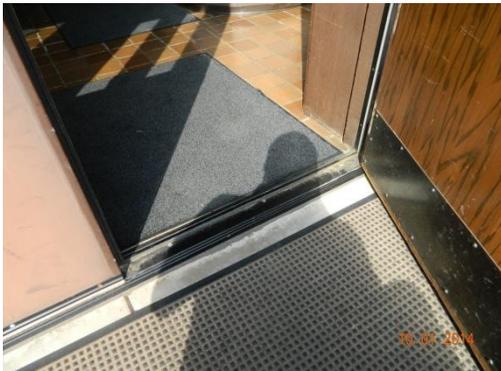
- 1.43

Non-compliance: The entry door threshold is not compliant.

Solution: Install compliant threshold.

Cost: \$300

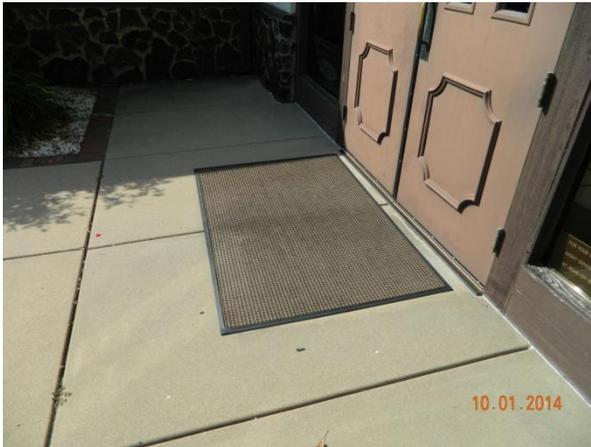
- 1.49
Non-compliance: The edges of the entry mat are not securely attached to the floor.
Solution: Securely attach entry mat to the floor.
Cost: \$50

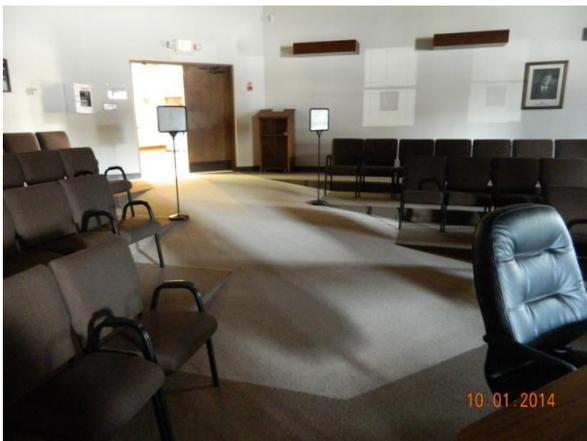
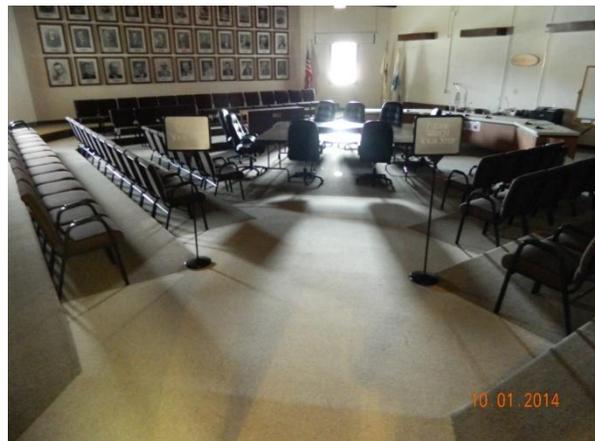
- 2.15
Non-compliance: The ramp in the Council Chambers does not have handrails.
Solution: Install continuous compliant handrails on both sides of the ramp.
Cost: \$1,500

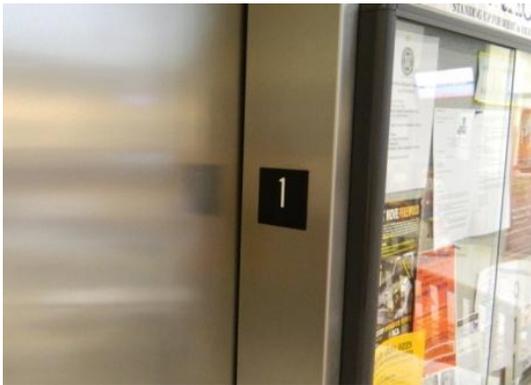
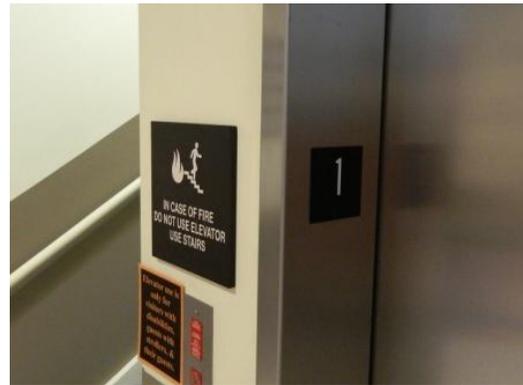
- 2.31
Noncompliance: There isn't a tactile star on the jambs at the main entry level.
Solution: Install signs with tactile stars.
Cost: \$100

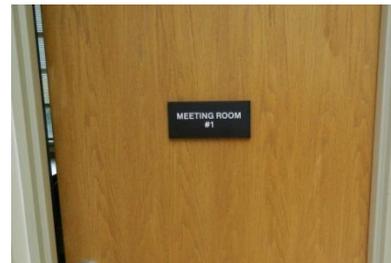
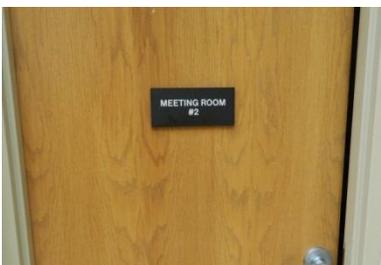
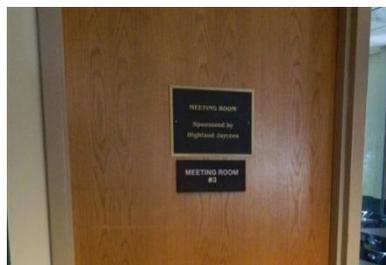
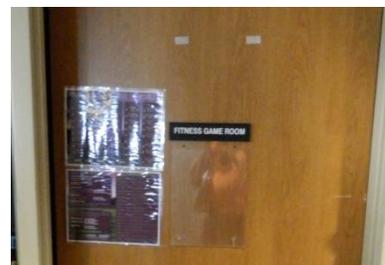
- 2.38
- **Noncompliance:** The signs at the child care room, second floor conference room, the second floor meeting rooms and the fitness game room are not located in a compliant location.
- **Solution:** Relocate tactile signs.
- **Cost:** \$300

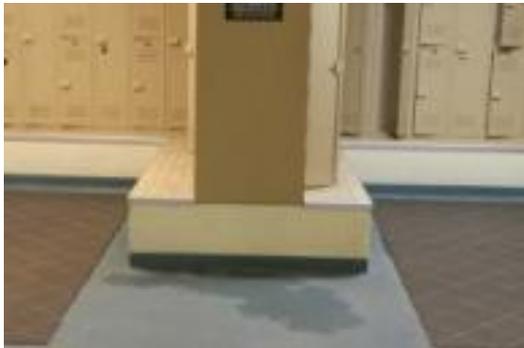
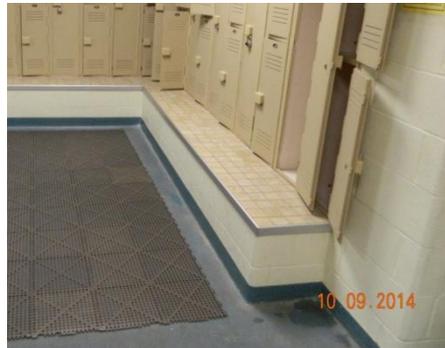
- 2.70
Noncompliance: The benches in the men's and women's locker rooms are only 15" deep.
Solution: Rework a 42" min. section of bench so it is at least 20" deep and no greater than 24" deep.
Cost: \$2000

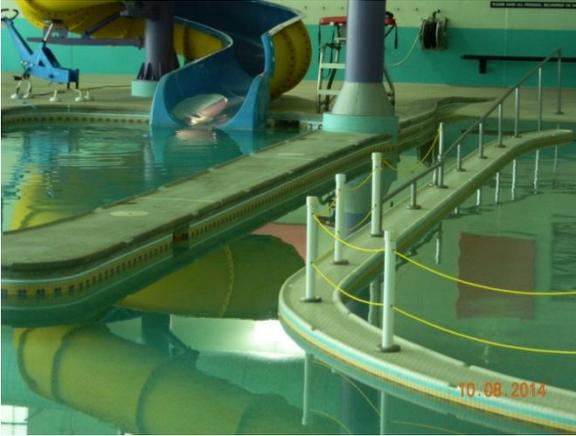
- P22
Verify that the pool lift has a weight capacity of at least 300lbs. If it does not comply, provide a new pool lift that does comply.
- P25
Noncompliance: The water depth at the end of the sloped entry is greater than 30"
Solution: Provide a landing located between 24 inches and 30 inches below the water level.
Cost: \$5,000

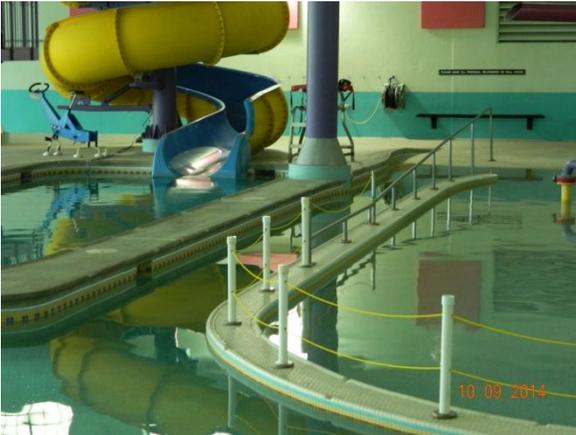
- P30
Noncompliance: The sloped entry does not have handrails on both sides.
Solution: Install compliant stainless steel handrails.
Cost: \$10,000

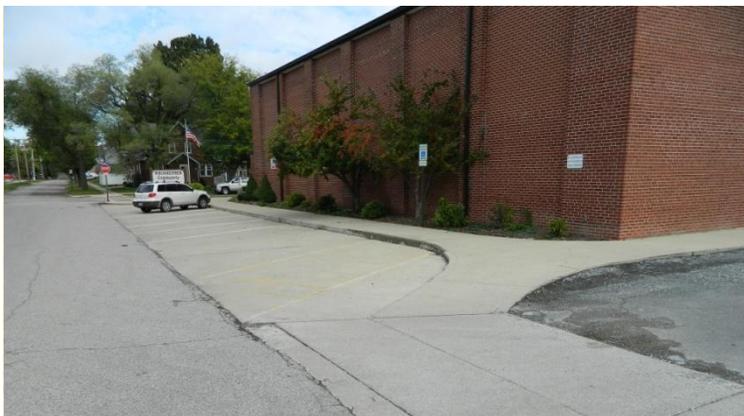
Non-compliance: The accessible space is not located on the closest accessible route.

Solution: Relocate the accessible space to the north and provide curb ramp.

Cost: \$2,000

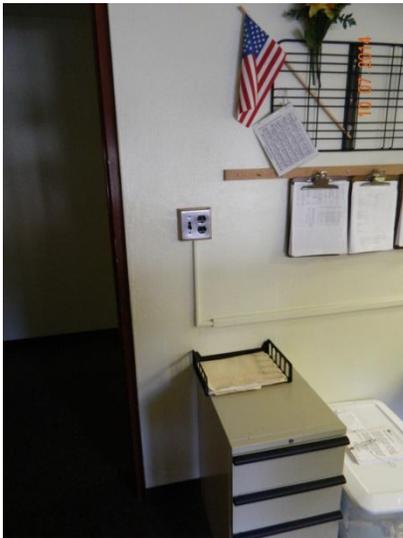
- 2.43
Non-compliance: Doors (approximately (4)) have knobs.
Solution: Replace knobs with lever hardware.
Cost: \$1,000
- 2.45
Non-compliance: The door near the reception counter exceeds 5 lbs to open.
Solution: Adjust/replace closer.
Cost: \$50 - \$500
- 2.50
Non-compliance: The light switch in the reception area does not have a 30" x 48" clear floor space.
Solution: Move the furniture.
Cost: \$50

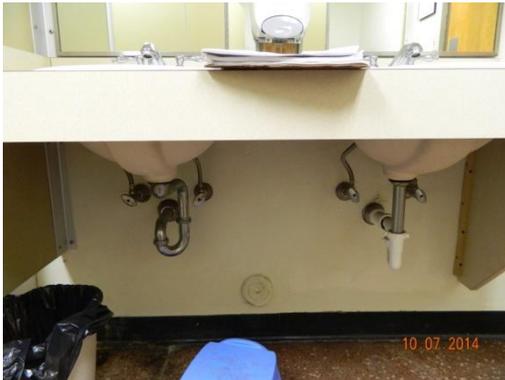
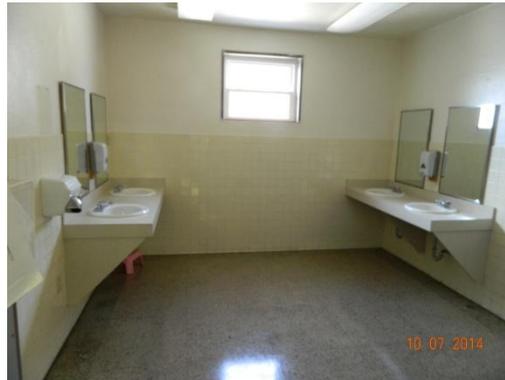
- 3.26
Non-compliance: In both toilets the pipes below the lavatories are not insulated.
Solution: Insulate pipes.
Cost: \$100

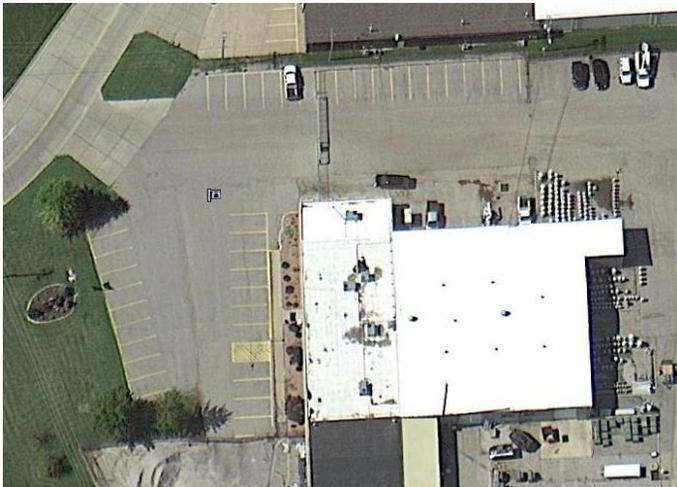
- 1.11

Non-compliance: There is no sign that reads "van accessible" at the accessible parking space.

Solution: Provide sign that reads "van accessible".

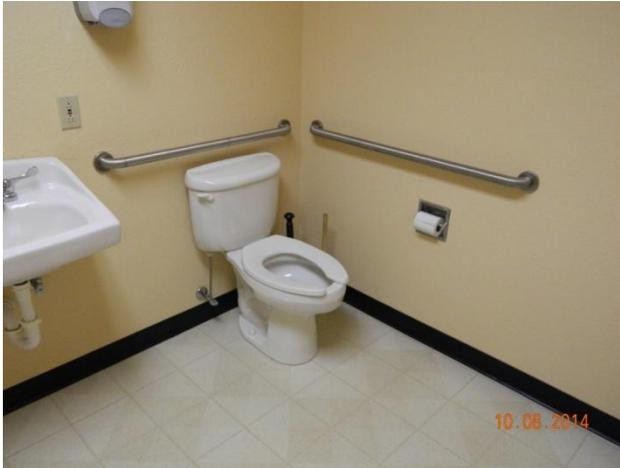
- 3.33
Noncompliance: The grab bar along the side wall in the toilet does not extend at least 54" from the rear wall.
Solution: Move grab bar.
Cost: \$50

- 3.34 – see photo from 3.33
Noncompliance: The grab bar along the rear wall in the toilet does not extend at least 24" to the open side from the centerline of the toilet.
Solution: Move grab bar.
Cost: \$50

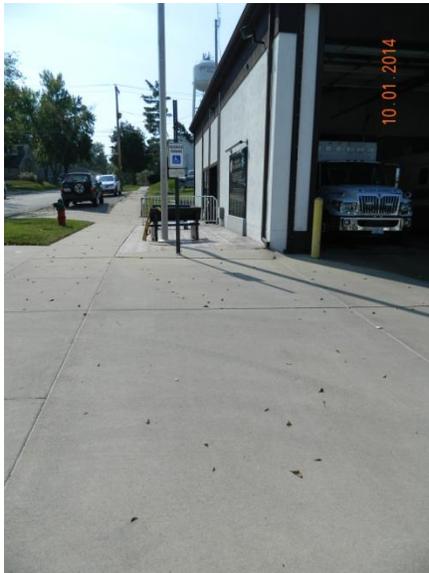
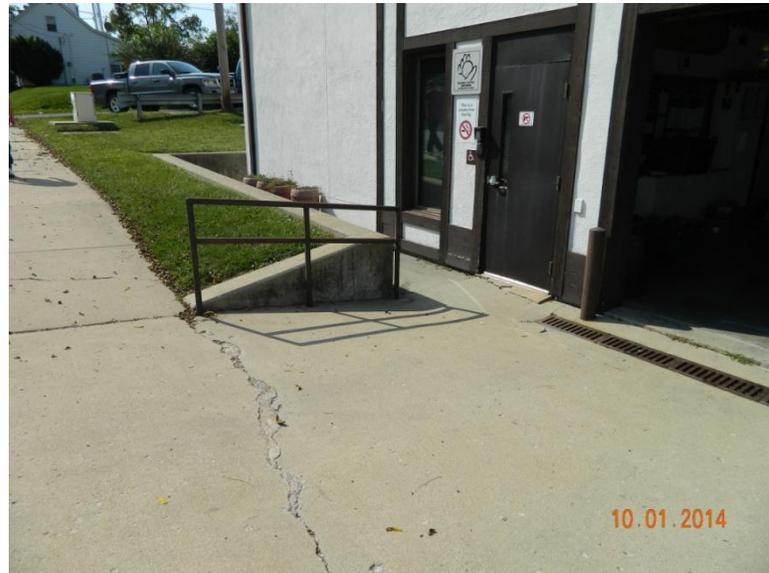
The single accessible space provided is not striped. The space cannot be striped with an access aisle because the aisle would encroach into the overhead door opening. The layout of the site does not allow the space to be moved to a better location. Provide striping at the edges of the accessible space but not for an access aisle. There is a sloped driveway, which acts as the approach to the main entrance, with a slope which exceeds 1:20. The handrail provided along the drive leading to the main entrance does not have 12" extensions at the top and bottom.

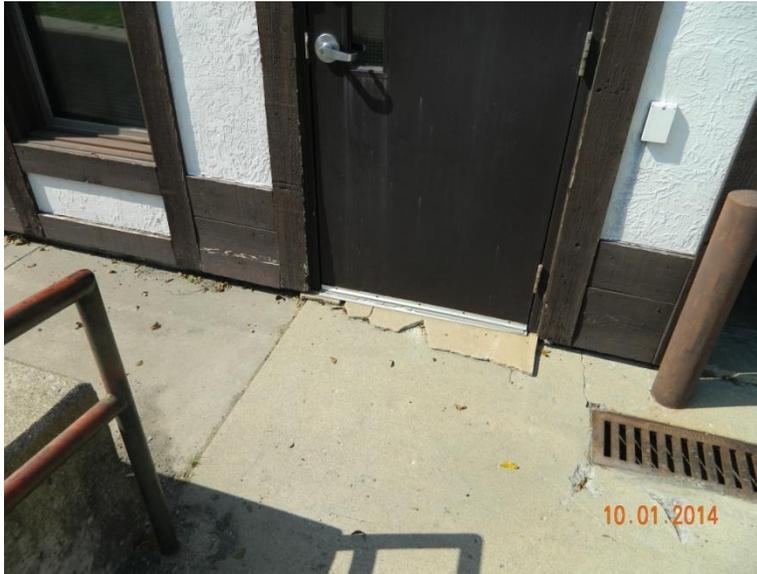
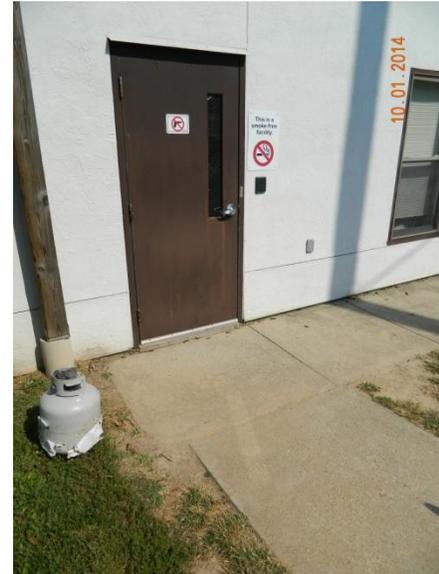
The main entry door is 2"-3" above the sidewalk. At some point concrete was poured to make a transition from the sidewalk into the building. The concrete transition is cracked and deteriorated. The main entry door takes less than 5 seconds to close. The back entrance does not have a sign showing the location of the nearest "accessible" entrance.

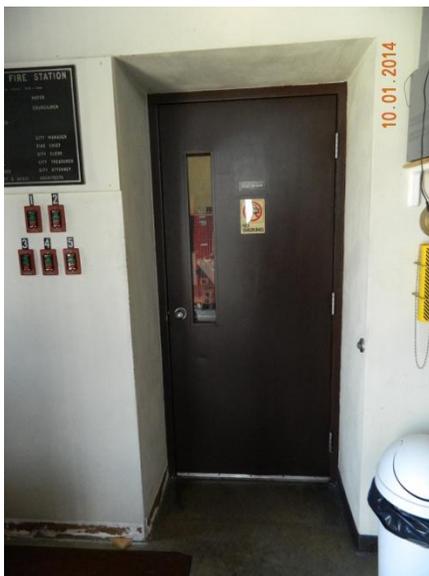
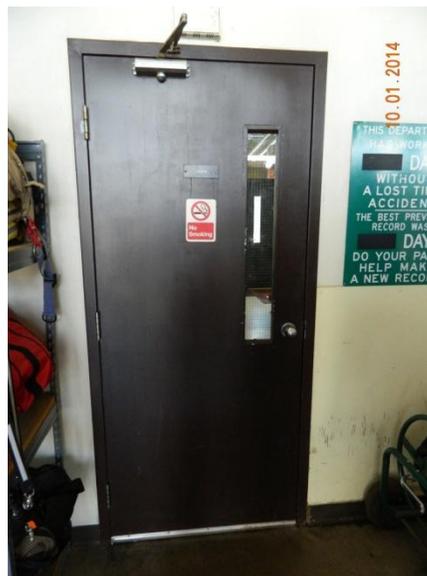
None of the room signs are compliant. The signs are not tactile (Note: "Tactile characters" are read using touch, i.e. raised characters and Braille) and do not have raised characters, nor are they mounted in the correct location. All of the interior doors have noncompliant hardware and require more than 5 lbs max. to open. Some of the doors take less than 5 seconds to close.

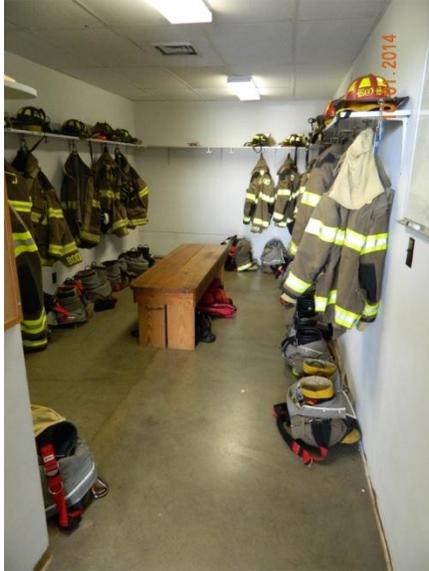
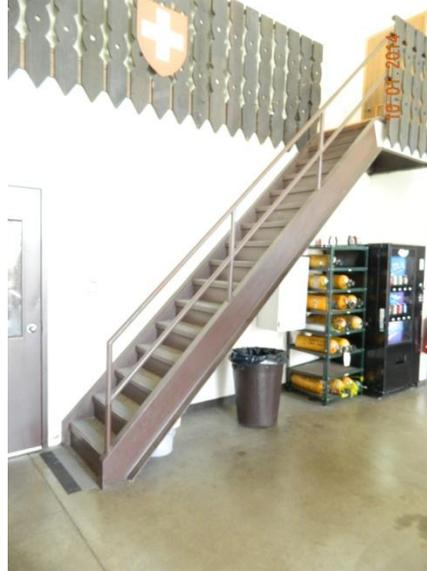
The bench in the dressing room is 22" high. This exceeds the allowable accessible height. There is no accessible route to the upstairs sleeping rooms.

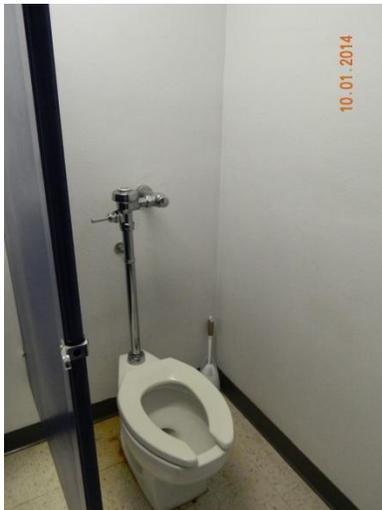
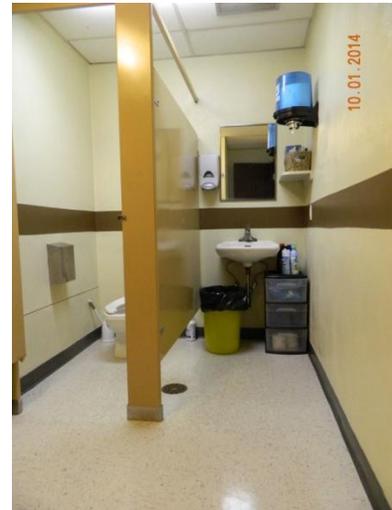
The men's and women's toilets / showers are not accessible. The doors leading into the toilets are 2'-4" wide, and there is no room to easily make them 3'-0". The required floor clearances for toilets and showers cannot be met in the existing spaces. There are no grab bars located on the walls, nor is there space on the rear walls to install compliant grab bars.

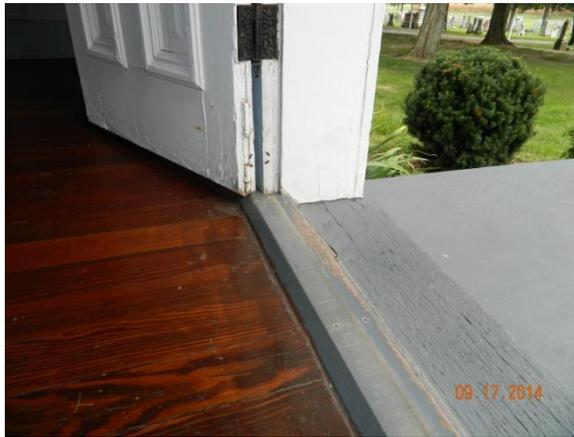
- 1.41
Noncompliance: The clear opening width of the entrance door is less than 32".
Solution: Replace doors.
Cost: \$3,000
- 1.43
Noncompliance: The threshold height exceeds 3/4 inches.
Solution: Replace threshold.
Cost: \$100

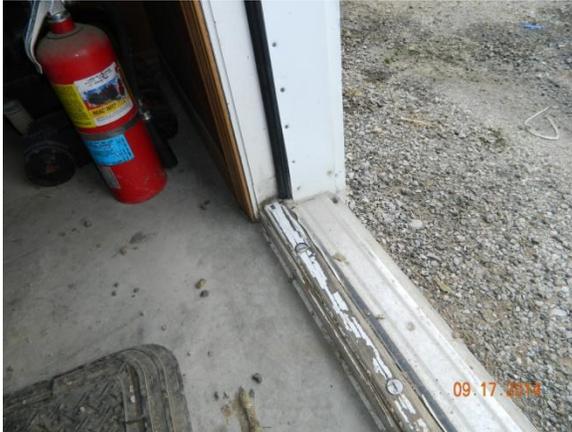
- 1.43
Noncompliance: The threshold height exceeds 3/4 inches.
Solution: Replace threshold.
Cost: \$100

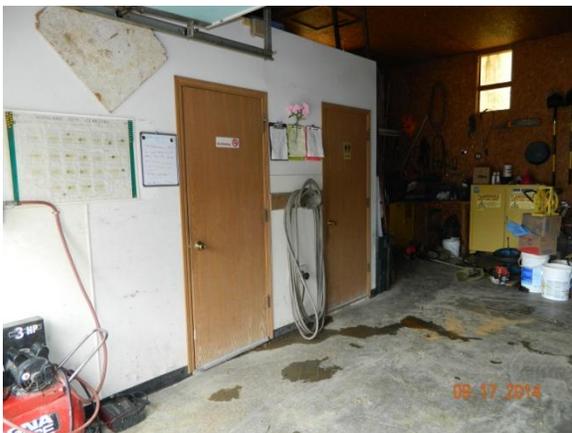
- 2.2
Noncompliance: There is a 1 1/2 inch change in level between the office and the work space and between the restroom and the work space.
Solution: Construct landing and short compliant ramp in work area.
Cost: \$1000

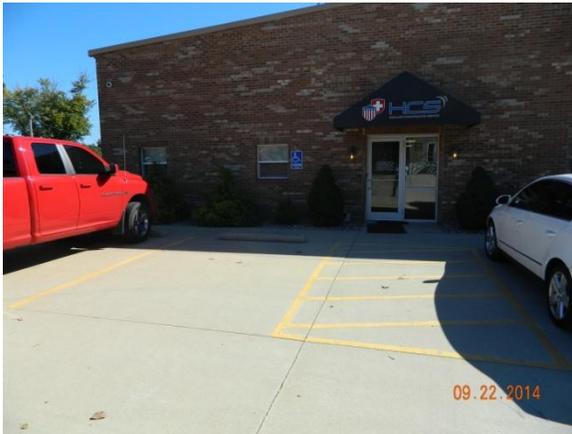
- **1.10**
Noncompliance: The bottom of the accessible parking sign is not 60 inches or more above the ground.
Solution: Raise sign.
Cost: \$100

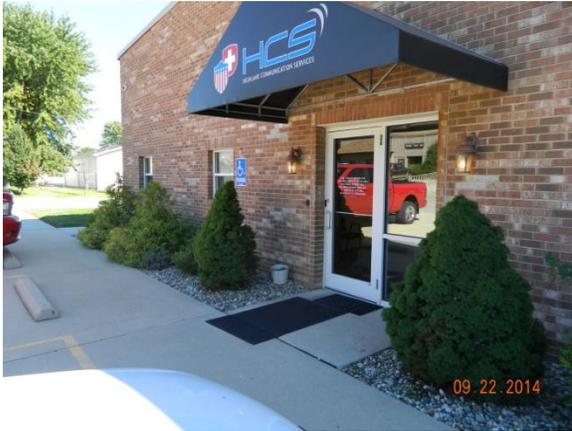
- 1.46
Noncompliance: The force to open the entrance door exceeds 5 pounds and the door closes in less than 5 seconds.
Solution: Adjust closer.
Cost: \$25

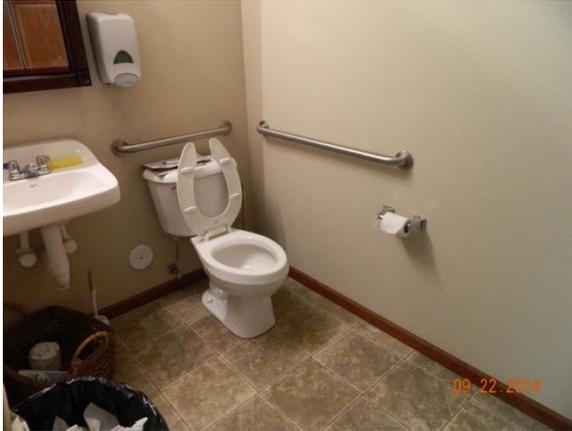
- 3.34
Noncompliance: The rear wall grab bar is not at least 36 inches long.
Solution: Install new compliant grab bar.
Cost: \$200

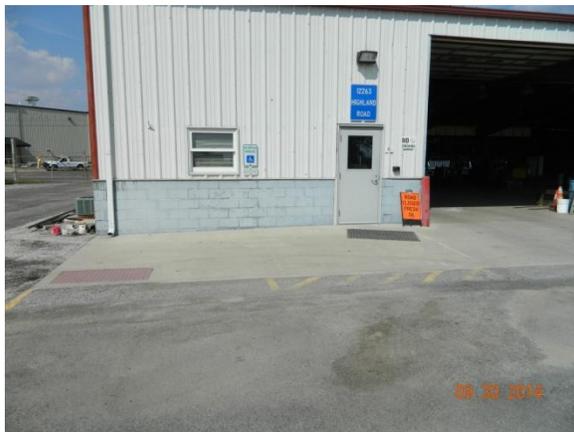
- **1.7**
Noncompliance: The accessible parking space and access aisle are not clearly marked.
Solution: Restripe accessible parking space and access aisle.
Cost: \$150
- **1.10**
Noncompliance: The bottom of the accessible parking sign is not 60 inches or more above the ground.
Solution: Raise sign.
Cost: \$50
- **1.11**
Noncompliance: There is no sign identifying the accessible parking space as van accessible.
Solution: Provide van accessible parking sign.
Cost: \$100

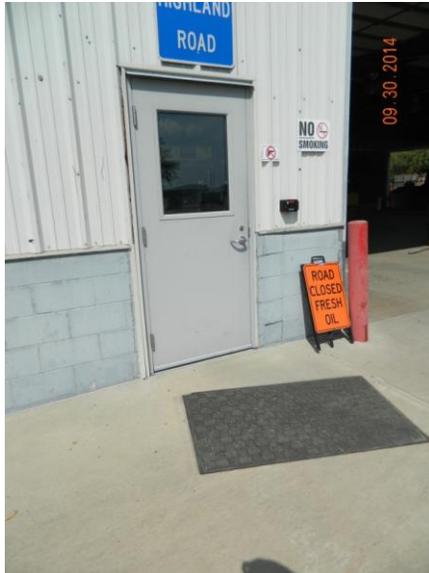
- 1.46

Noncompliance: The force to open the entrance door exceeds 5 pounds and the door closes in less than 5 seconds.

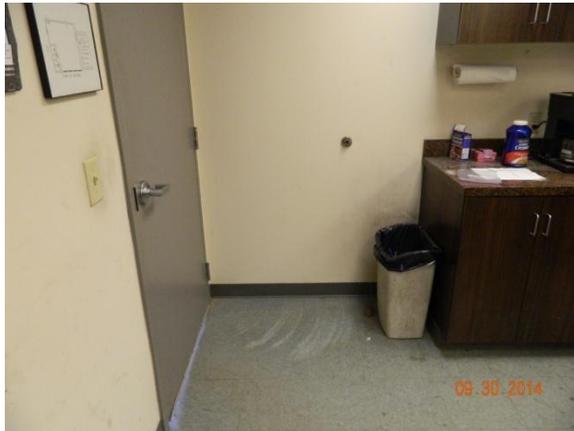
- 2.41
Noncompliance: The door to the break room does not have the required maneuvering clearances on either side of the door.
Solution: Remove door closer.
Cost: \$25

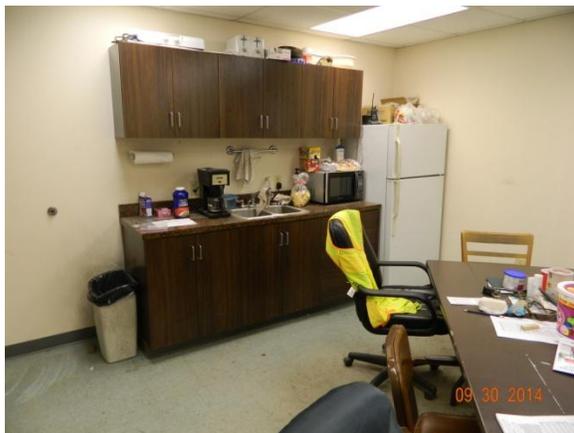
- 2.45 & 2.46
Noncompliance: The force required to open the office door exceeds 5 pounds and door closes in less than 5 seconds.
Solution: Adjust or replace closer.
Cost: \$25 - \$250
- Miscellaneous
Noncompliance: The sink in the break room does not have a clear space for forward approach with knee and toe clearance and is higher than 34 inches above the floor.
Solution: Rework cabinets and countertop to provide lower sink with required clearances.
Cost: \$500

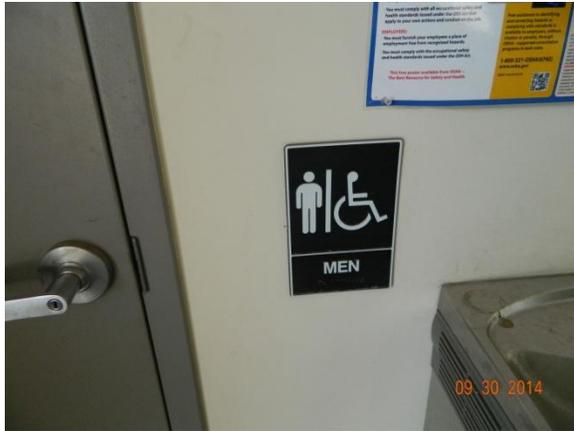
- 3.5
Noncompliance: The signage at the restrooms is mounted below 48 inches above the floor.
Solution: Relocate the signs to be between 48 and 60 inches above the floor.
Cost: \$100

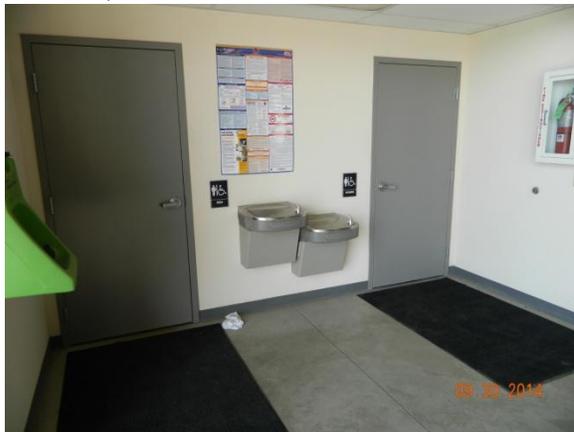
- 3.7
Noncompliance: The restroom doors do not have the required maneuvering clearance outside the room.
Solution: Relocate fire extinguisher and emergency eye wash. Relocate drinking fountain or provide drinking fountain that does not impede on maneuvering clearances.
Cost: \$3,500

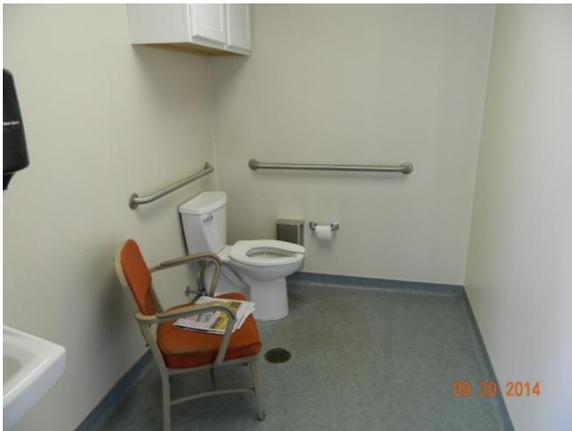
- 3.33 & 3.34

Noncompliance: The grab bars are mounted with the top 37 inches above the floor.

Solution: Reinstall grab bars with the top between 33 and 36 inches above the floor.

Cost: \$150

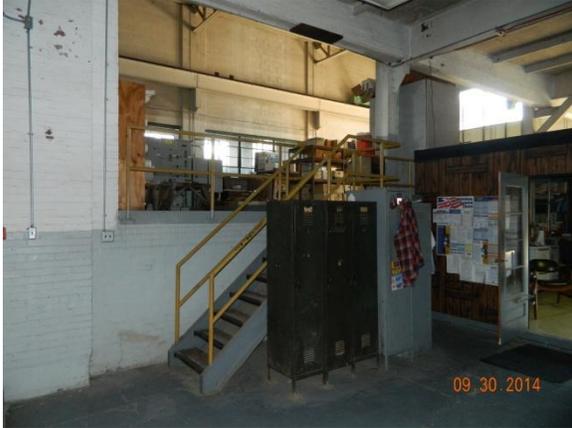
- 2.2
Noncompliance: The offices are not located on an accessible route.
Solution: Relocate offices and provide landings and short ramps as needed.
Cost: \$5,000

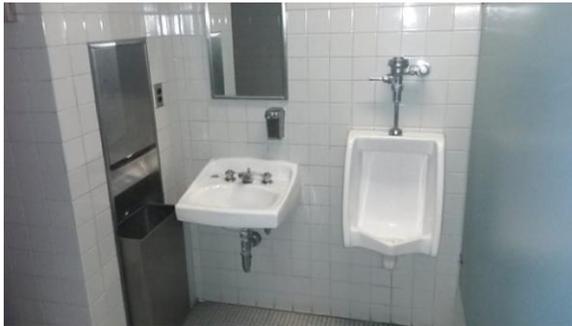
- 3.19
Noncompliance: Bottom edge of reflecting surface of mirror is greater than 40" above finish floor.
Solution: Replace mirror, install at 40" above finish floor.
Cost: \$100

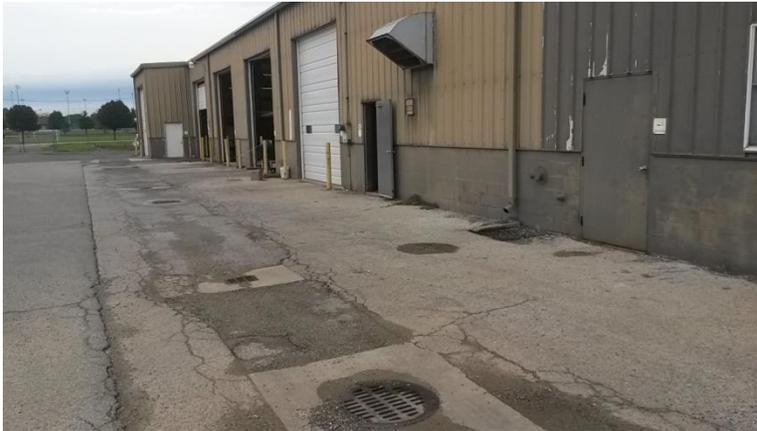
- **1.2**
Noncompliance: There is no designated accessible parking space.
Solution: Provide accessible parking space and access aisle.
Cost: \$2,500

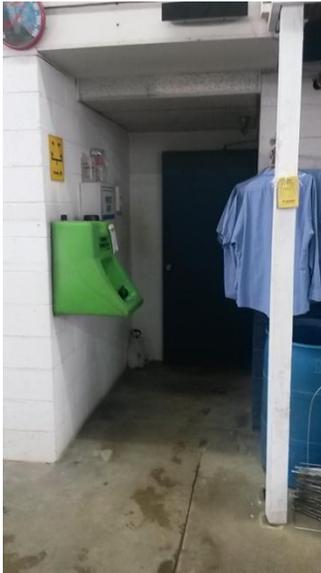
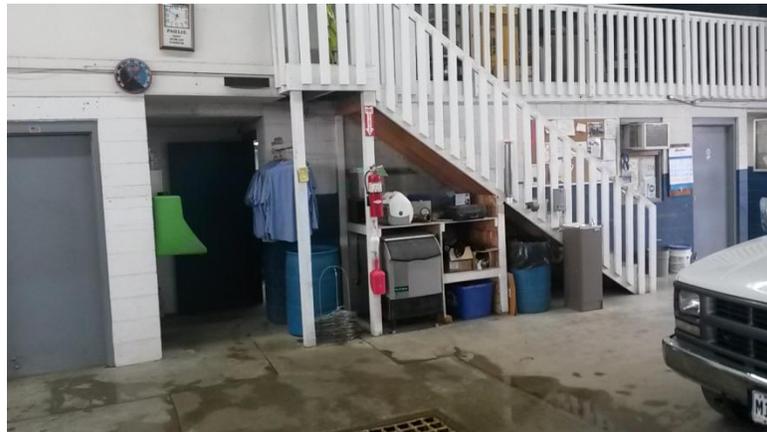
- **2.8**
Noncompliance: The emergency eyewash, office air conditioner, hand sanitizer, time clock and first aid kit protrude more than 4 inches from the wall and are greater than 27 inches above the floor.
Solution: Relocate protruding objects.
Cost: \$250

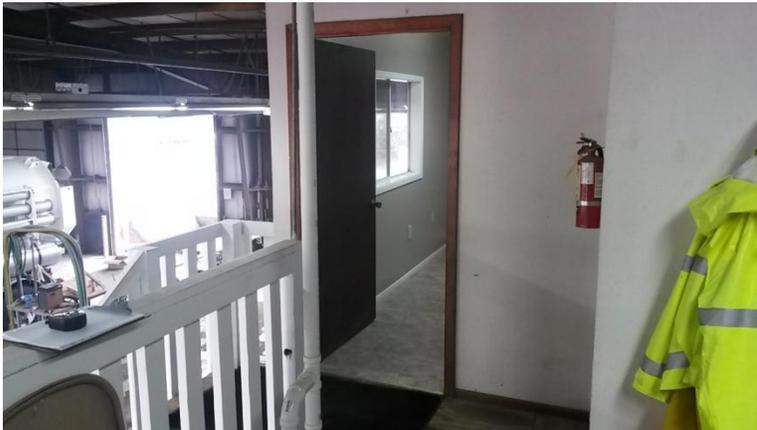
- **2.41**
Noncompliance: The door into the break room does not have the required maneuvering clearance.
Solution: Reconfigure wall and door so that it is at least 48 inches from the stairs and railing.
Cost: \$1,500

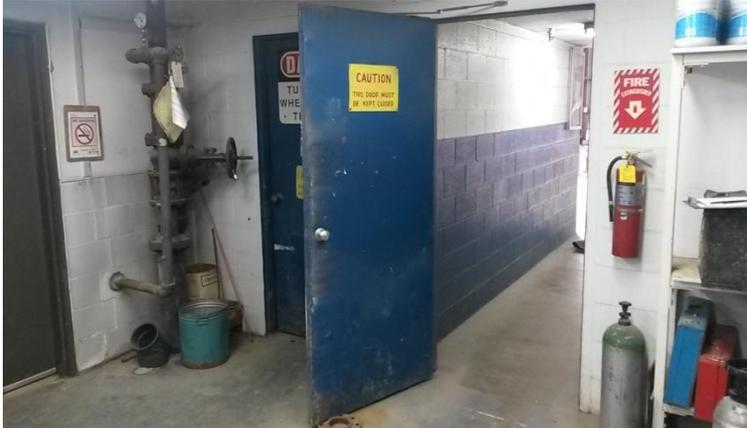
- 2.41
Noncompliance: The door into the southwest work room does not have the required maneuvering clearances.
Solution: Remove door closer.
Cost: \$25
