Americans with Disabilities Act Transition Plan

City of Highland
1115 Broadway
P.O. Box 218
Highland, IL 62249-0218

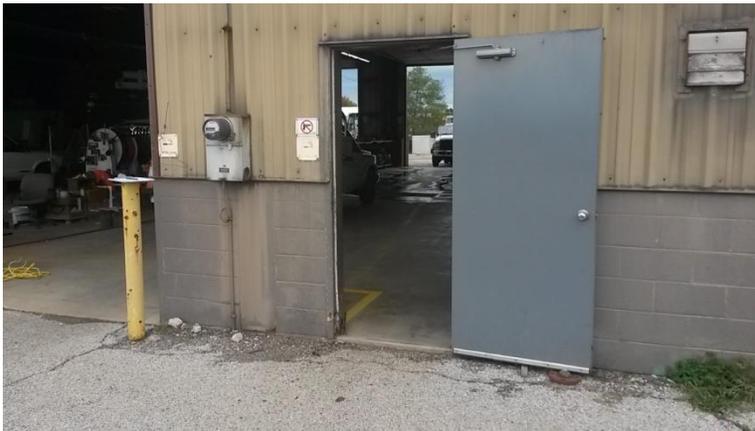
- 2.41
Noncompliance: The main (west) egress door does not have the required 12 inch maneuvering clearance at the latch side.
Solution: Reverse the hinge side of the door.
Cost: \$250

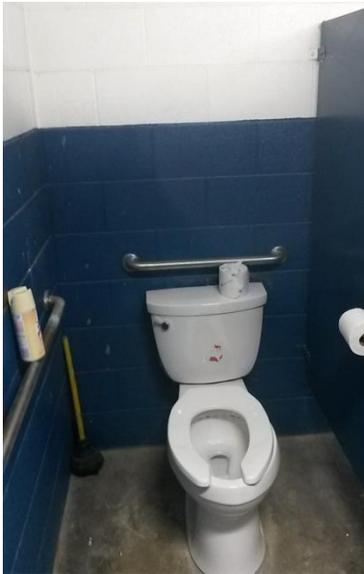
- 3.30
Noncompliance: The water closet is not located between 17 and 19 inches from the side wall.
Solution: Relocate water closet or fur out wall.
Cost: \$500

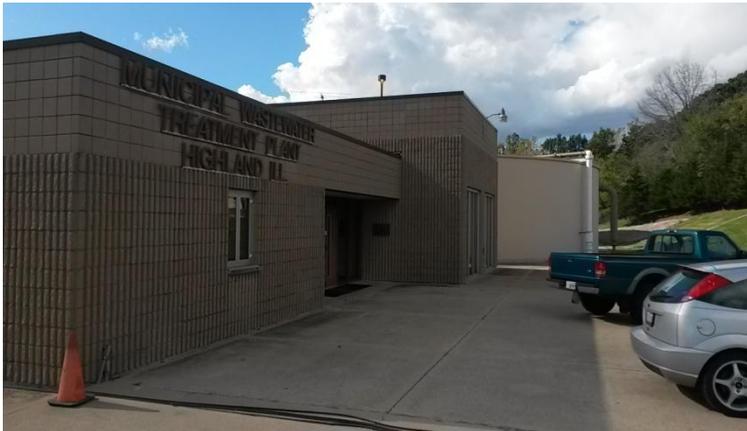
- **1.2**
Noncompliance: There is no designated accessible parking space.
Solution: Stripe parking lot to provide accessible parking space and access aisle.
Cost: \$150

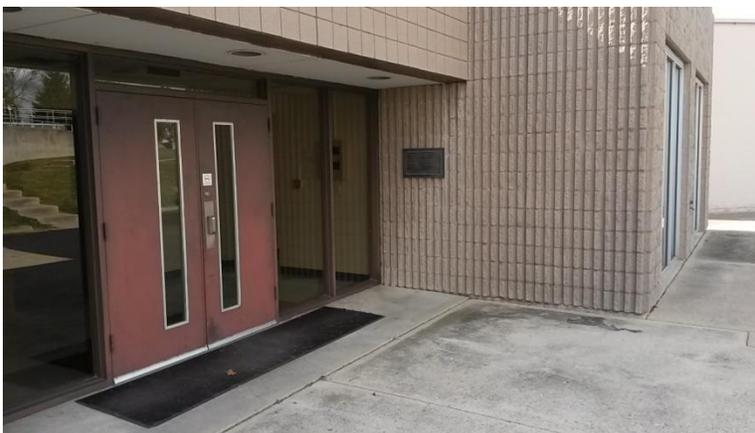
- **1.46**
Noncompliance: The force to open the entrance door exceeds 5 pounds and the door closes in less than 5 seconds.
Solution: Adjust closer.
Cost: \$25

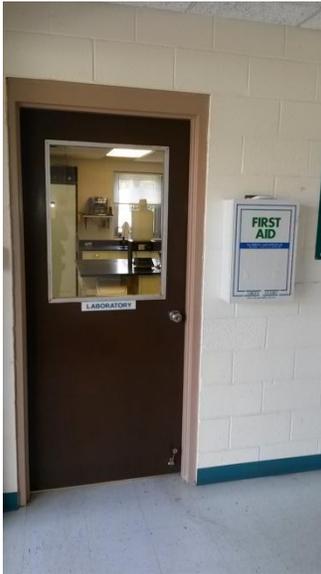
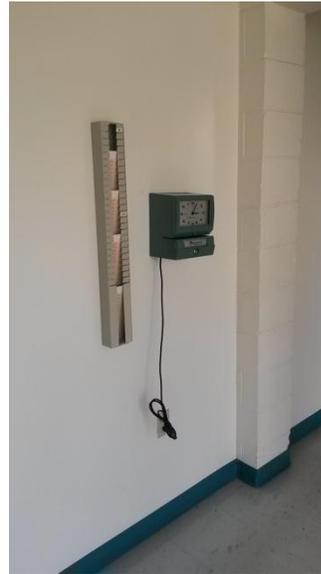
- 2.8
Noncompliance: The time clock and first aid kit protrude greater than 4 inches from the wall and are between 27 and 80 inches above the floor.
Solution: Lower items so that bottom is 27 inches or less above the floor or provide a permanent barrier below items that is.
Cost: \$500

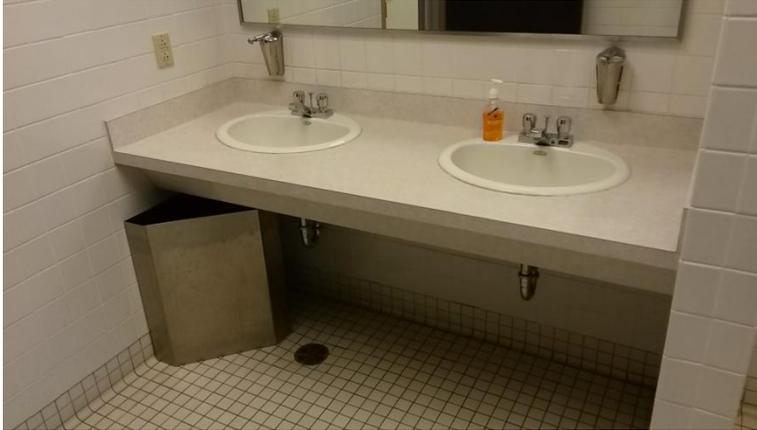
- 3.19
Noncompliance: The mirror in the locker room is mounted with the bottom higher than 40 inches above the floor.
Solution: Remove soap dispensers and lower mirror.
Cost: \$100

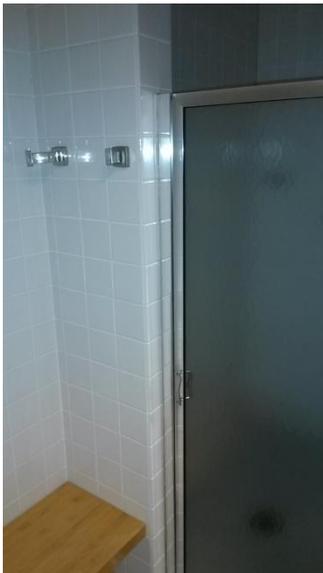
- 3.20
Noncompliance: The hooks in the shower area are mounted above 48 inches above the floor.
Solution: Lower hooks or provide new hooks below 48" above the floor.
Cost: \$50

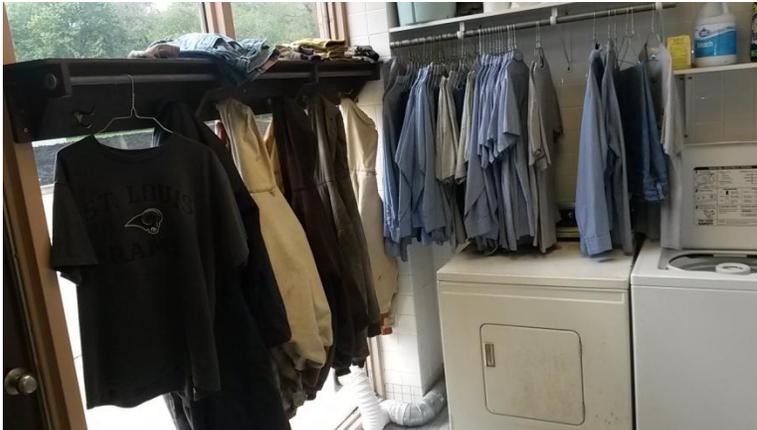
Noncompliance: The hanging rods and hooks are mounted greater than 48 inches above the floor.

Solution: Provide hanging space that is 48 inches or less above the floor.

Cost: \$100

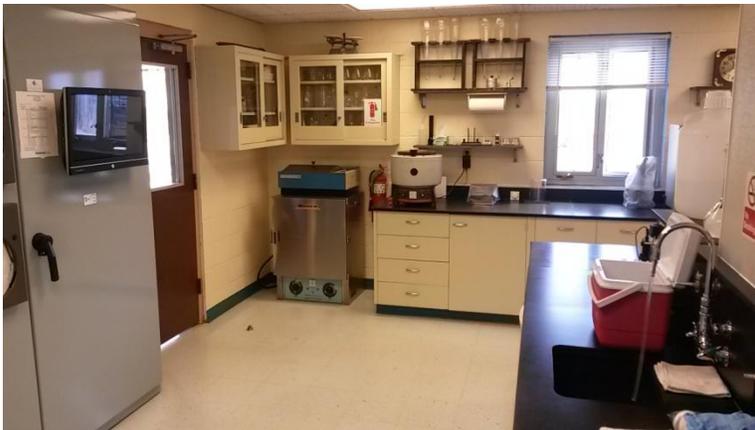
Noncompliance: The work surfaces in the lab are higher than 34 inches above the floor.

Solution: Provide a work surface at 34 inches above the floor with knee and tow clearances.

Cost: \$1,000

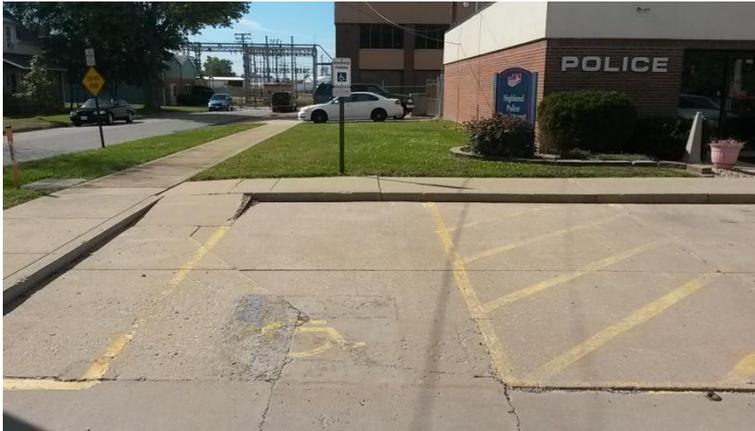
- 1.9
Non-compliance: The access aisle does not connect to an accessible route.
Solution: Provide curb ramp.
Cost: \$2,000

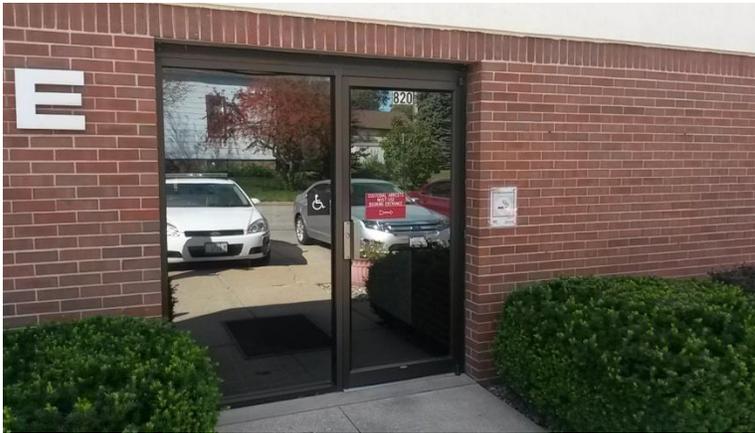
- 1.46
Non-compliance: The force to open the entrance door and vestibule doors exceeds 5 pounds and the doors close in less than 5 seconds.
Solution: Adjust closers.
Cost: \$50

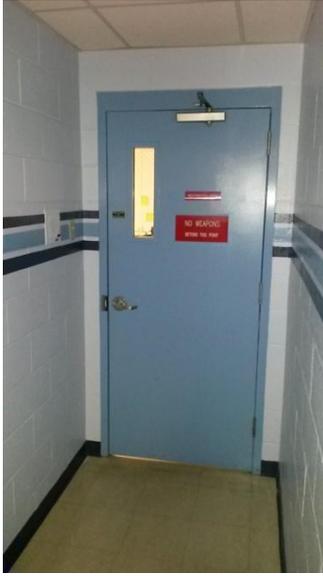
- 2.41
Non-compliance: The door into Booking does not have the required maneuvering clearance.
Solution: Reverse swing of door or Install door operator.
Cost: \$250 or \$5,500

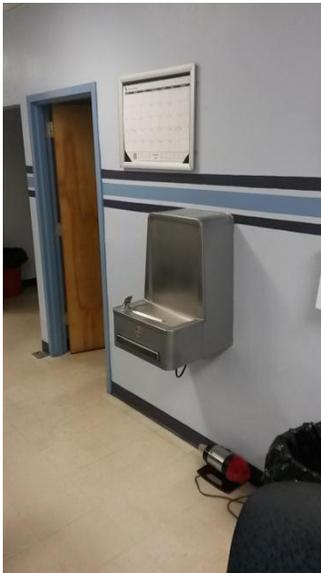
- **4.6**
Non-compliance: The spout on the drinking fountain is greater than 36 inches above the floor.
Solution: Lower drinking fountain.
Cost: \$250

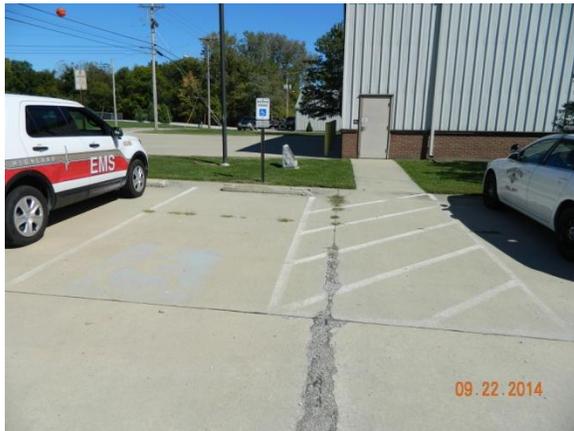
- **1.10**
Noncompliance: The bottom of the accessible parking sign is not 60 inches or more above the ground.
Solution: Raise sign.
Cost: \$100

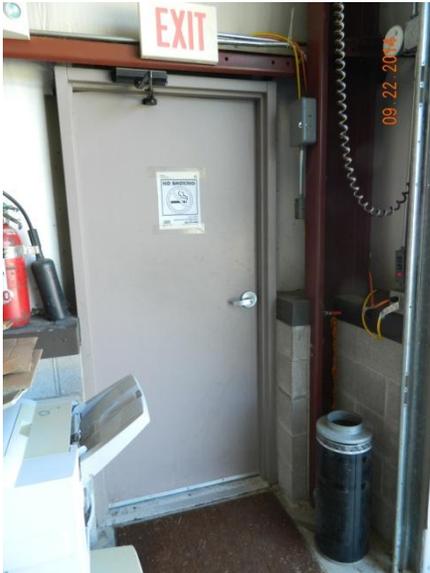
Noncompliance: The exit door does not have the required 12 inch maneuvering clearance at the latch side.

Solution: Reverse hinge side of door.

Cost: \$500

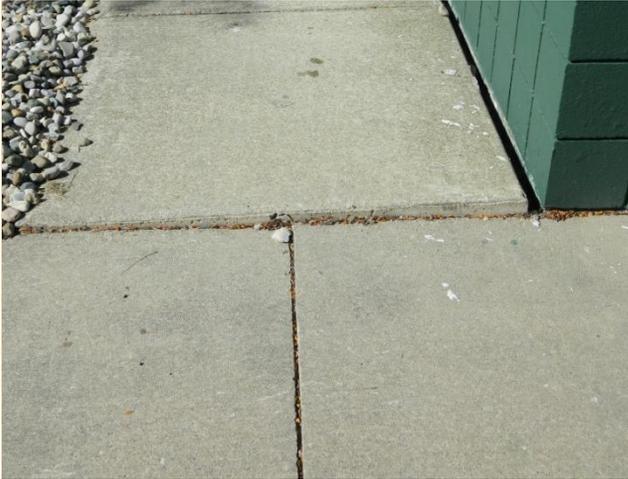
- Miscellaneous

Noncompliance: There is no accessible route from the concrete to the interior of the dugouts at Optimist Field. It requires walking on the turf and cinder walk and there is a 1" transition from the ground to the top of the dugout floor.

Solution: Replace the section of sidewalk to provide an even surface.

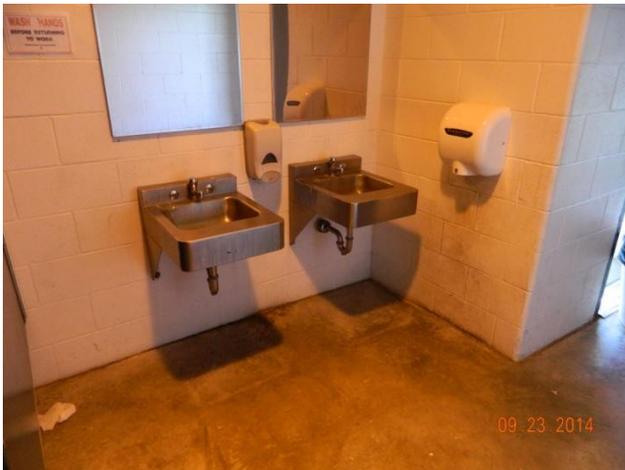
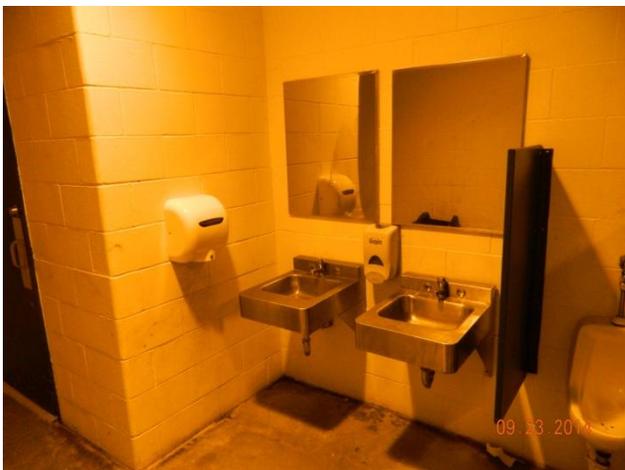
- 3.19
Noncompliance: In both toilets the mirrors are mounted greater than 40" above the floor.
Solution: Move mirrors.
Cost: \$100

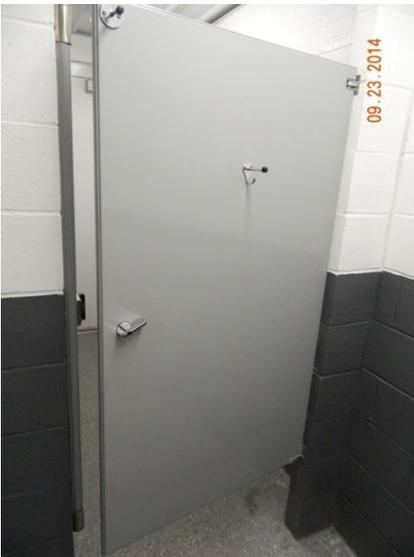
- 3.20

Noncompliance: In both toilets the coat hooks are mounted greater than 48" above the floor.

Solution: Move coat hooks or provide new coat hooks at accessible height.

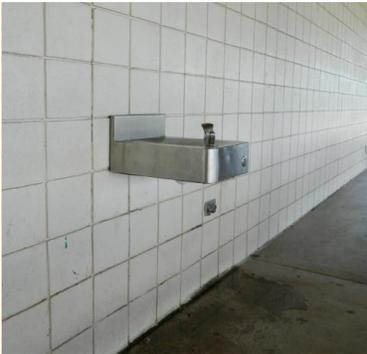
- 4.9:
Noncompliance: The drinking fountain sticks out into the path of travel more than 4" and the leading edge of the drinking fountain is more than 27" above the ground.
Solution: Adjust height of drinking fountain.
Cost: \$200

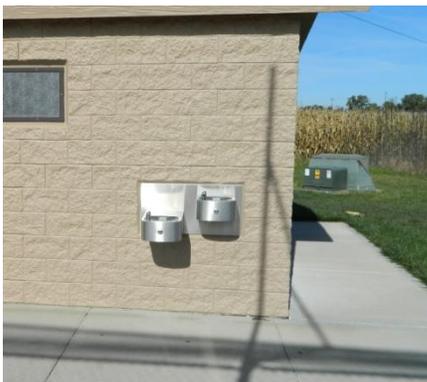
- 4.9:
Noncompliance: The drinking fountain sticks out into the path of travel more than 4" and the leading edge of the drinking fountain is more than 27" above the ground.
Solution: Adjust height of drinking fountain.
Cost: \$300

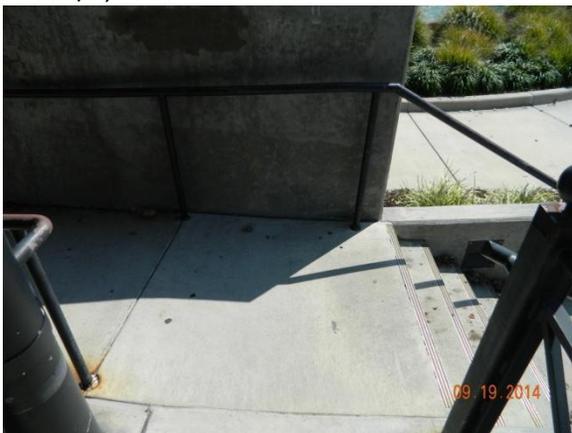
- **2.13**
Noncompliance: The top ramp landing is not 60 inches long.
Solution: Extend landing.
Cost: \$1,000

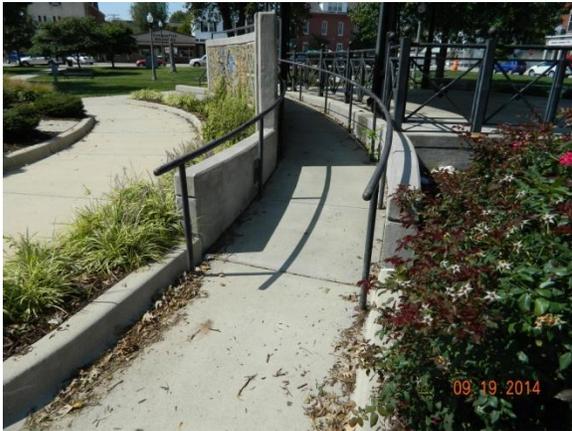
- 2.20
Noncompliance: The handrail extensions at the top of the ramp do not extend 12 inches on one side and is not horizontal on the other.
Solution: Modify handrail extensions.
Cost: \$750

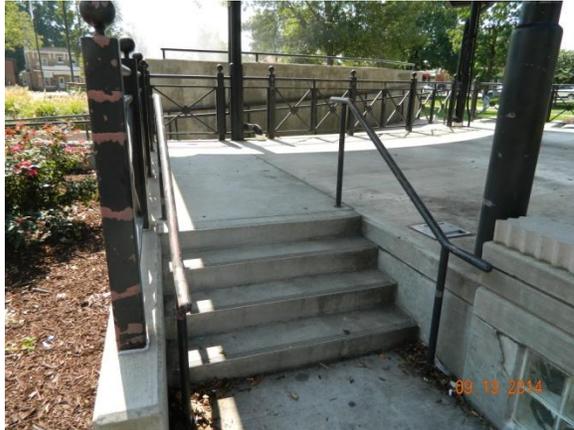
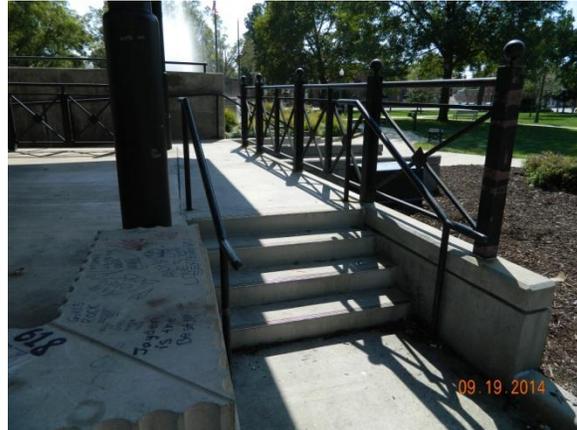
Noncompliance: The stair handrails are less than 34 inches above the stair nosings and/or landings and do not return to a wall, guard or landing.

Solution: Replace handrails.

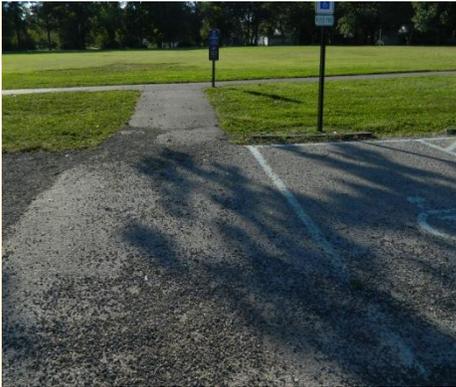
Violation: The south accessible parking space access aisle does not adjoin an accessible route.

Solution: Move accessible parking space so it adjoins the other accessible route to the south.

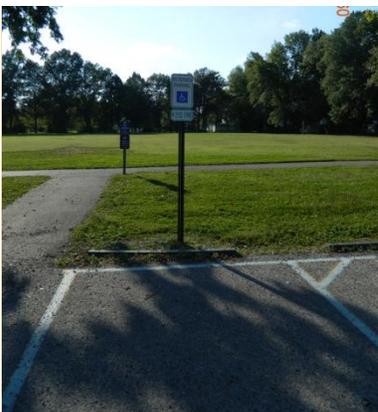
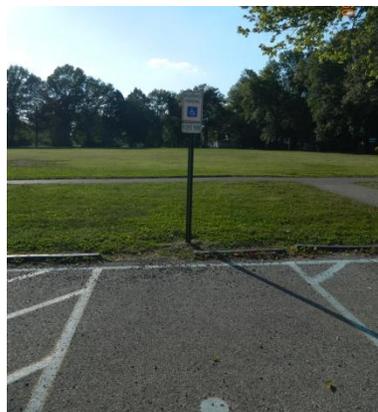
• 1.11

Violation: There are not signs that read "van accessible" at the accessible parking signs.

Solution: Provide signs that read "van accessible".

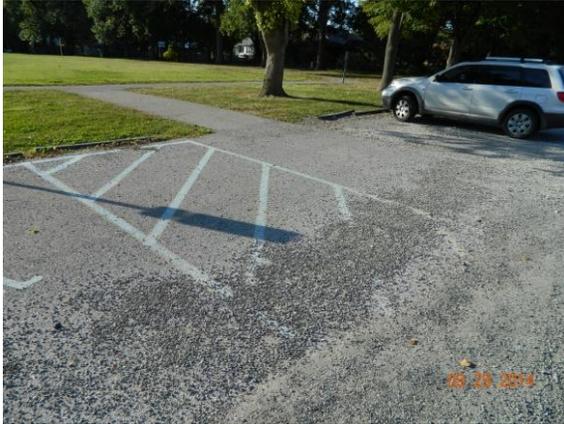
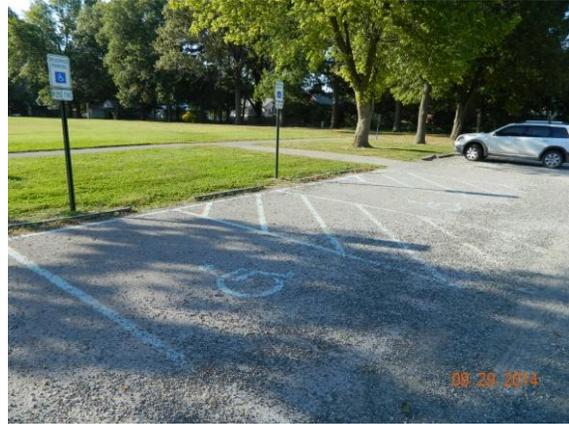
Violation: There is gravel covering the accessible parking spaces across from the tennis courts.

Solution: Remove the gravel from the parking spaces.

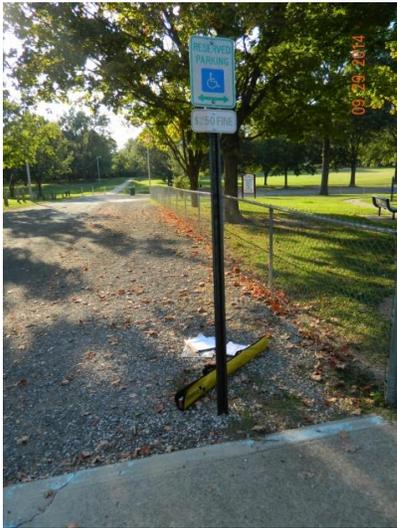
- 1.11

Violation: There is no sign that reads "van accessible" at the accessible parking sign.

Solution: Provide sign that reads "van accessible".

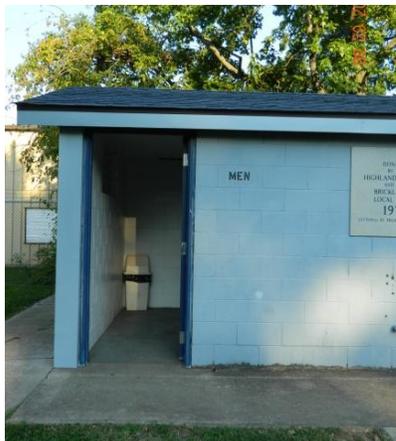
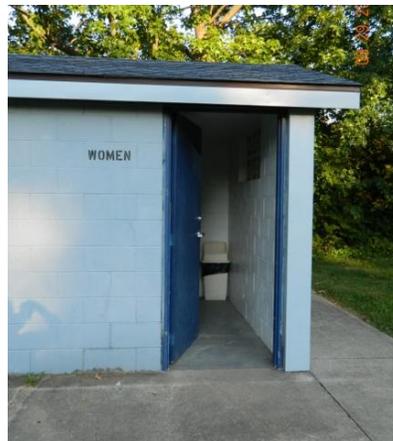
Violation: The clear floor space on the pull side of the door is less than 18".

Solution: Reverse the doors to swing opposite or swing doors outward.

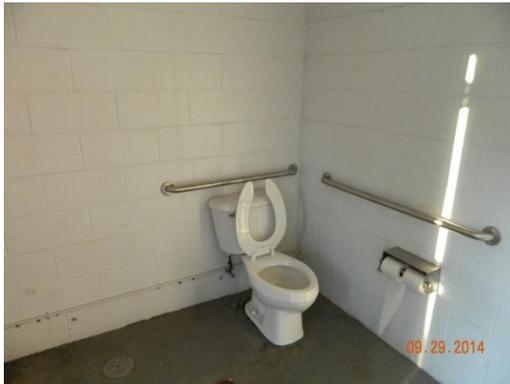
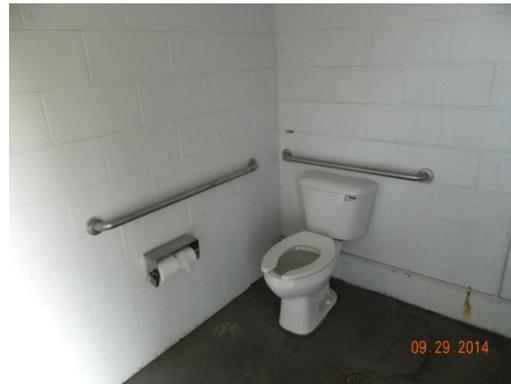
Violation: The grab bars on the rear wall in each toilet do not extend at least 24" from the centerline of the water closet to the open side of the room.

Solution: Relocate grab bars.

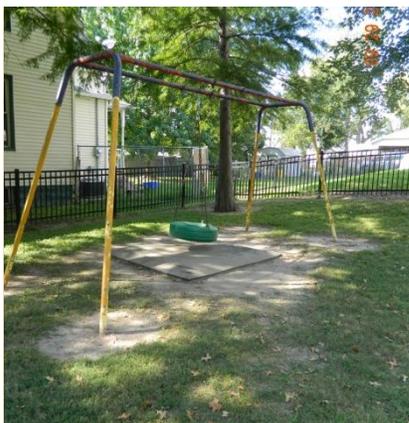
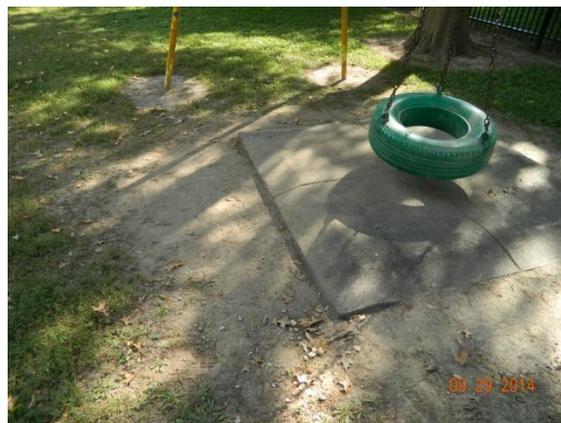
- Miscellaneous

Noncompliance: There is not an accessible route from the playground to the tire swing.

Solution: Provide an accessible route from the playground to the tire swing.

Cost: \$2,500

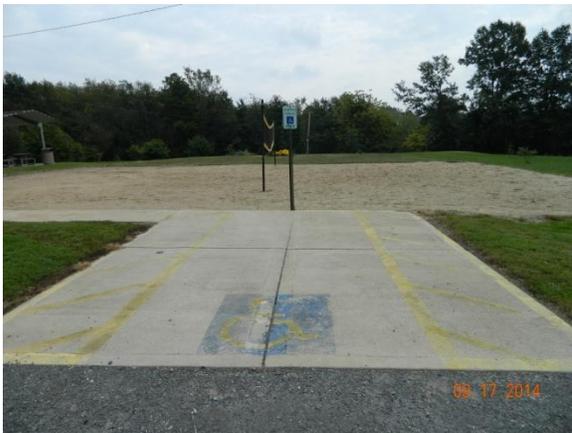
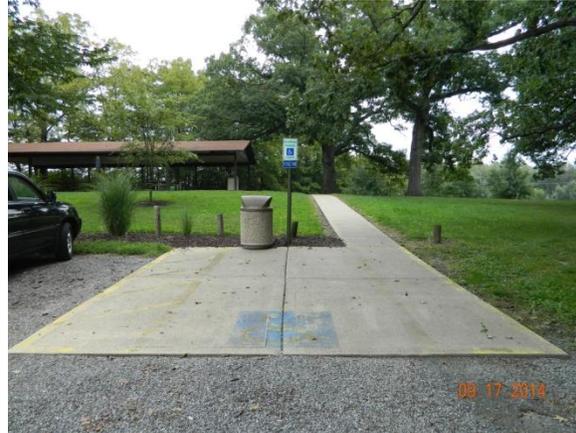
1.2 - 1.12: Parking

- 1.3
Noncompliance: A van accessible parking space is not provided at the sand volleyball court, Silver Lake Pavilion and at restrooms and veteran’s memorial near boat access.
Solution: Restripe parking spaces.
Cost: \$500
- 1.8
Noncompliance: Slope of accessible parking spaces near the sand volleyball court, at Silver Lake Pavilion, at restrooms near boat access, at boat access and at veteran’s memorial exceed 1:48.
Solution: Construct required, compliant accessible parking spaces.
Cost: \$10,000

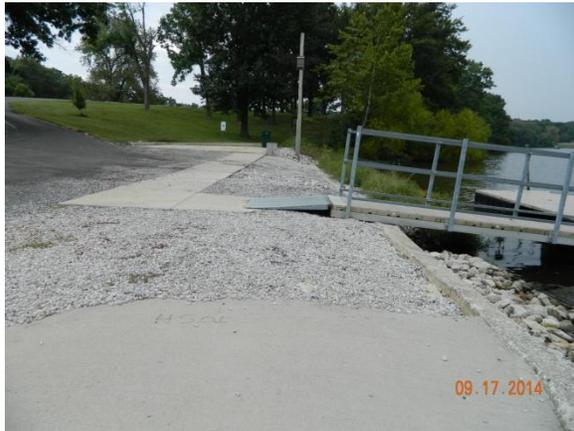
- **B4**
Noncompliance: The slope of the gangway exceeds 1:12, does not have compliant handrails and edge protection.
Solution: Replace gangway with a longer, compliant gangway.
Cost: \$1,500

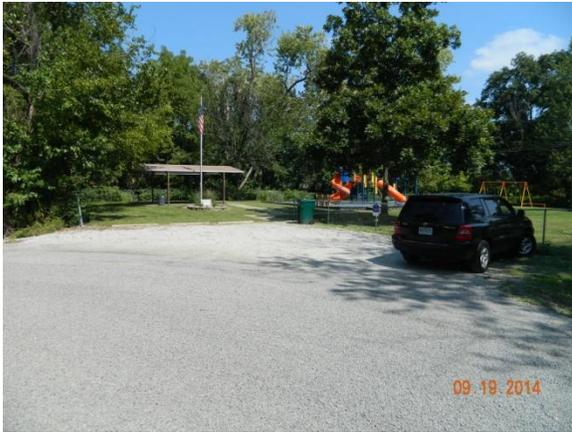
1.2 - 1.12: Parking

- Noncompliance:** An accessible parking space is not provided.
Solution: Provide a van accessible parking space, access aisle and signage.
Cost: \$2,500

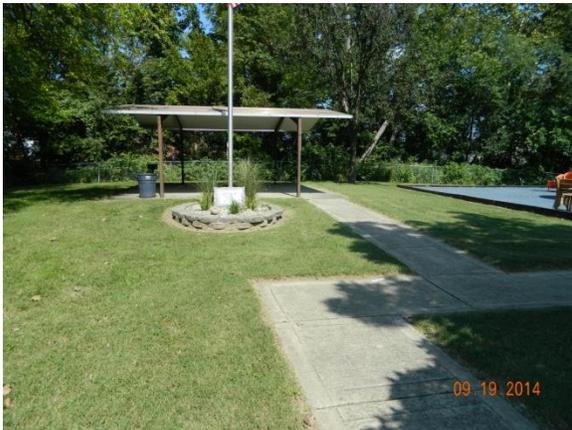
1.3 - 1.18: Accessible Route

- **1.17**
Noncompliance: The running slope of the route to the pavilion exceeds 1:20.
Solution: Regrade and reroute sidewalk.
Cost: \$1,500

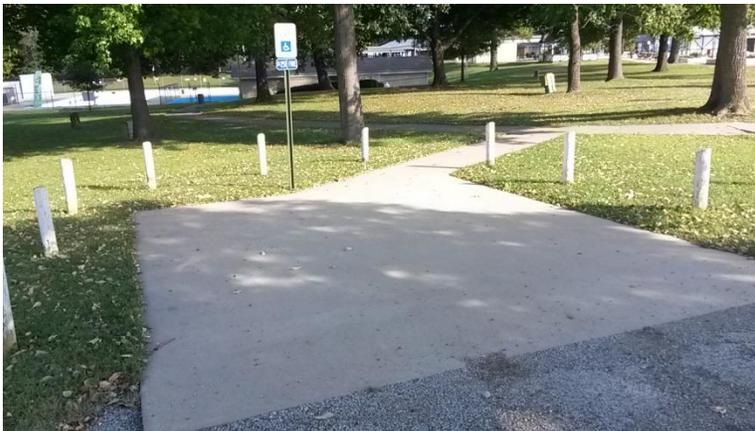
- 1.7
Noncompliance: The accessible parking space and access aisle is not clearly marked.
Solution: Restripe accessible parking space and access aisle.
Cost: \$150
- 1.8
Noncompliance: The slope of the accessible parking space and access aisle exceeds 1:48.
Solution: Remove and replace paving.
Cost: \$3,000
- 1.11
Noncompliance: There is not a sign identifying the accessible parking space as van accessible.
Solution: Provide van accessible parking sign.
Cost: \$100

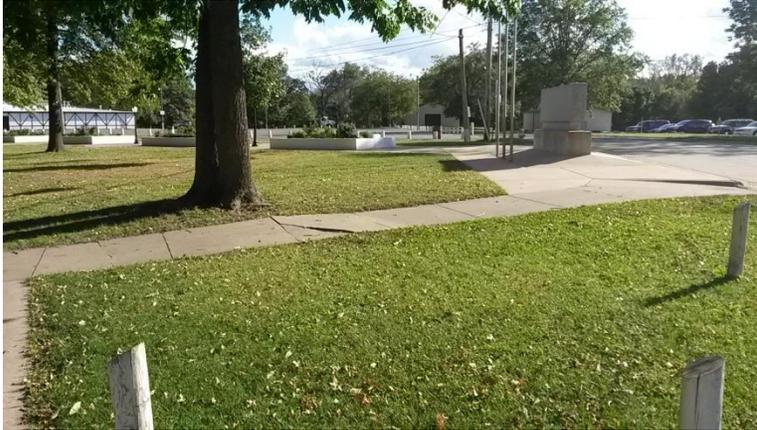
Noncompliance: Three sections of sidewalk near the parking and monument sign are broken and/or uneven.

Solution: Replace sections of sidewalk.

Cost: \$750

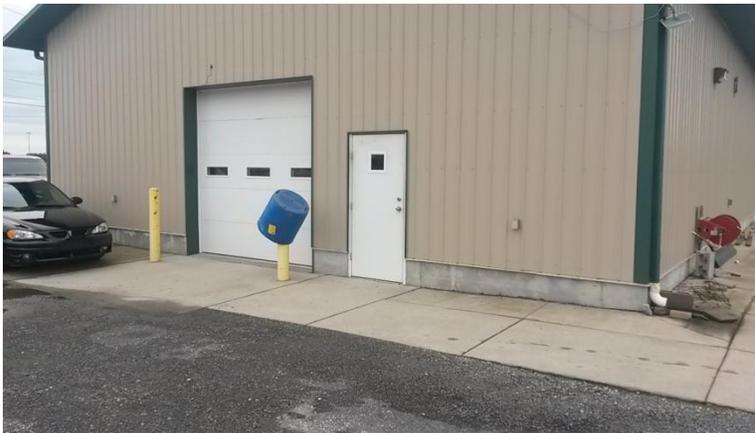
- 1.2
Noncompliance: There is no designated accessible parking space.
Solution: Stripe parking lot to provide accessible parking space and access aisle.
Cost: \$150

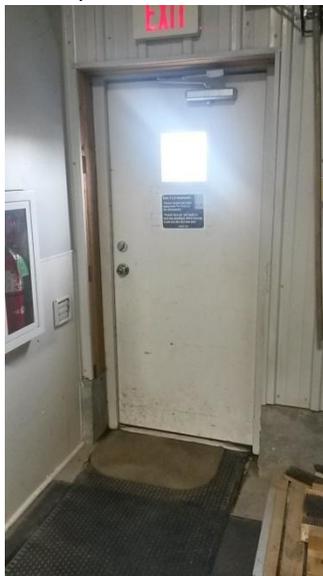
Noncompliance: The main (north) does not have the required 12 inch maneuvering clearance at the latch side.

Solution: Reverse the hinge side of the door.

Cost: \$250

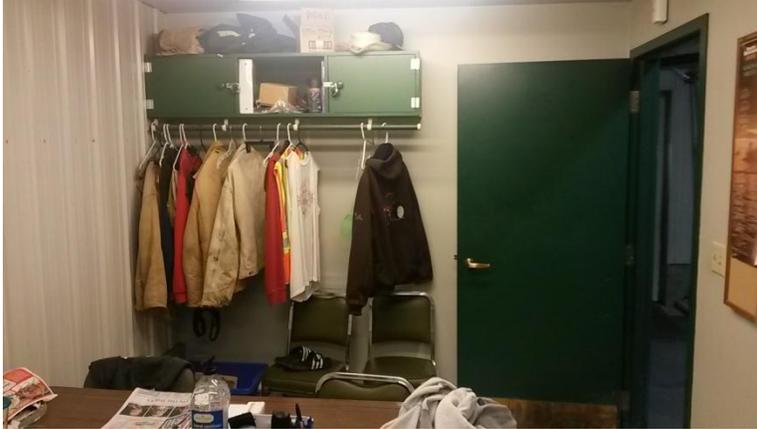
Noncompliance: The hanging rods and storage in the break room are mounted greater than 48 inches above the floor.

Solution: Provide hanging space and storage that is 48 inches or less above the floor.

Cost: \$100
